Case Study: De-Boning Line

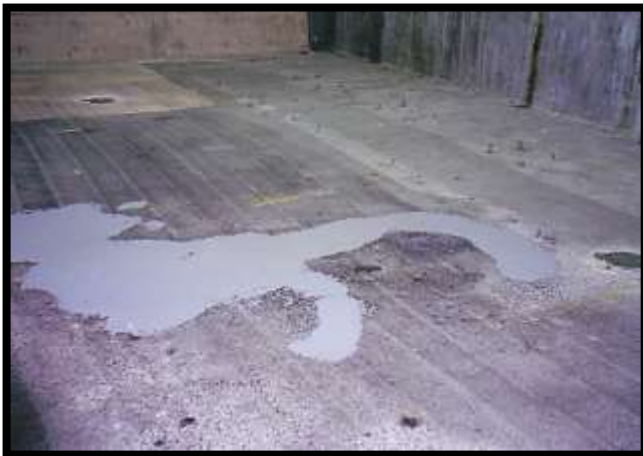
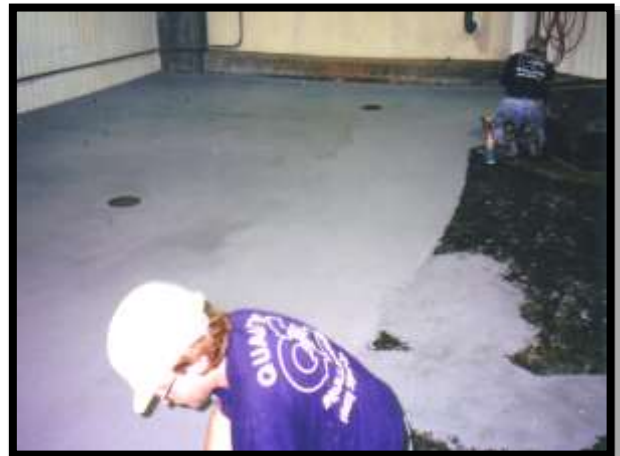
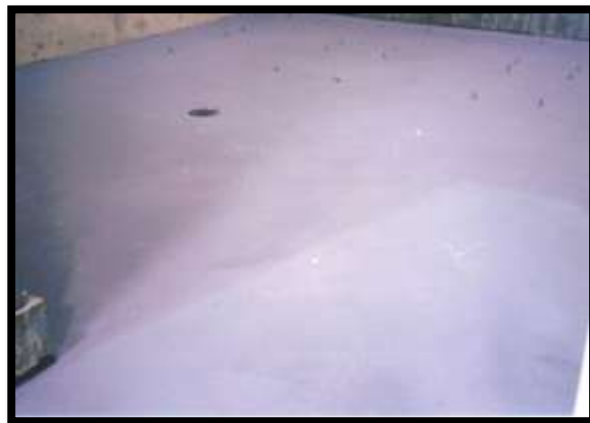
A poultry processing company experienced severe concrete spalling from many years of exposure to chicken bloods, fats, and caustic solution wash downs from their de-boning line. The potential for bacterial growth in standing water was a major concern.

All of the tables and equipment were removed. The concrete was de-greased and shotblasted to remove loose concrete and to provide the proper bonding profile. Areas with extreme damage were pre-filled with 3300 FS and allowed to cure. Entire floor was then primed with an epoxy primer and Milamar's 3300 FS was troweled over entire area at a thickness of $\frac{1}{4}$ " (6 mm).

The new surface allowed liquids to flow to the drains eliminating the concern for bacterial growth. The non-slip surface also provided an added safety feature for employees. The 3,800 ft.² (380 m²) was completed in three days including equipment removal.
