## Case Study: Itasca, IL Public Works Facility

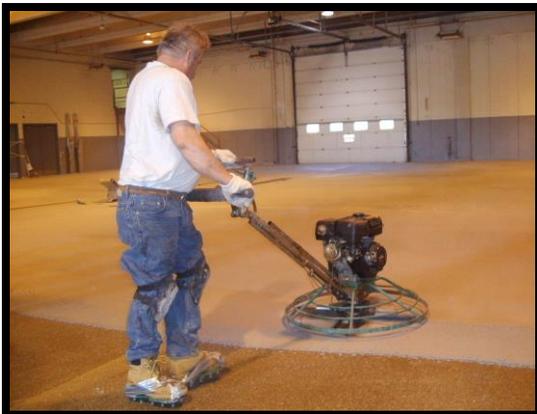
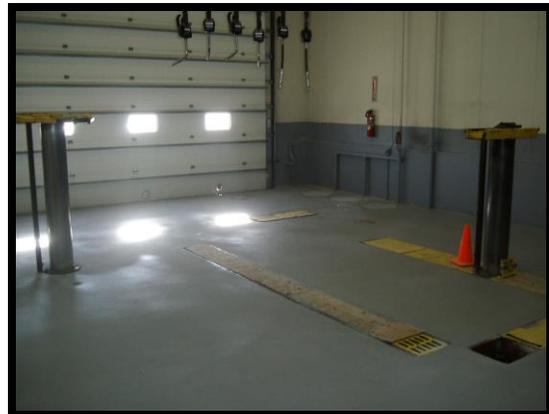
When the Fleet Manager for the Village of Itasca needed to repair the floor in their 16,000 sq. ft. garage/storage facility in a tight time frame he turned to Milamar Coatings for guidance. The facility is used to store their trucks, plows and heavy equipment and the floor is subjected to a lot of abuse, very heavy wear conditions, moisture and oil. He was seeking an environmentally friendly, long lasting, high performance floor that required a minimum of maintenance and he wanted it done right the first time so they wouldn't be bothered with frequent repairs. Milamar's ICO-Floor 51, 100% solids, trowelled epoxy flooring system was exactly what he was looking for. Its outstanding toughness, lack of odor, and single step application make it the ideal floor resurfacer in existing facilities such as this.

ConCare of Melrose Park, IL was chosen as the applicator for the job. The first step in the surface preparation was degreasing contaminated areas, followed by mechanical shot blasting to obtain a clean, abraded surface. All cracks 1/8" and greater were routed out and keyways were cut around the perimeter of all drains, trenches, metal protuberances and entryways. The floor was then primed with Milamar Coatings' 100% solids epoxy primer ICO Primer LV with rollers at an application rate of about 200-250 SF/gallon and allowed to dry tack free. Then ICO-Floor 51 was mixed and spread out on the floor using a screed box at 1/4" thickness, then power-trowelled (see photo) to level the surface and back rolled with an isopropyl alcohol-moistened roller to close the surface. Sand was then broadcast onto the floor until the preselected texture was achieved. No sealer coat was needed because of ICO Floor 51's resin rich mixture. Lastly the yellow safety striping and parking lanes were added using our high build, high wear ICO Floor Coating SY which was put down in a single coat.

The floor was finished and the garage was returned to service well within the required timeframe. The client was extremely happy with the quality and quickness of the installation and in the eleven months the floor has been in service there have been no issues.
