Case Study: Pork Processing Company

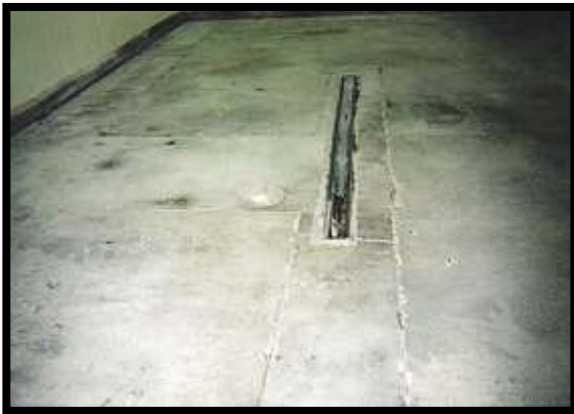
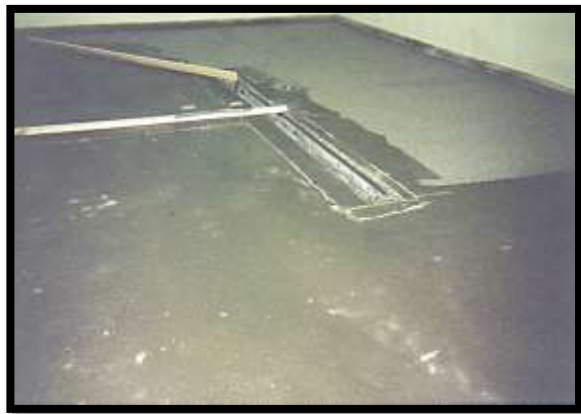
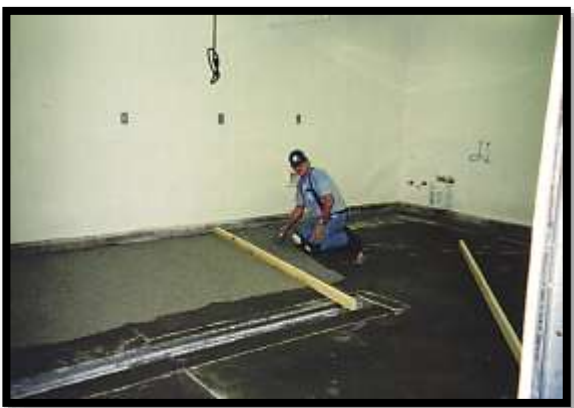
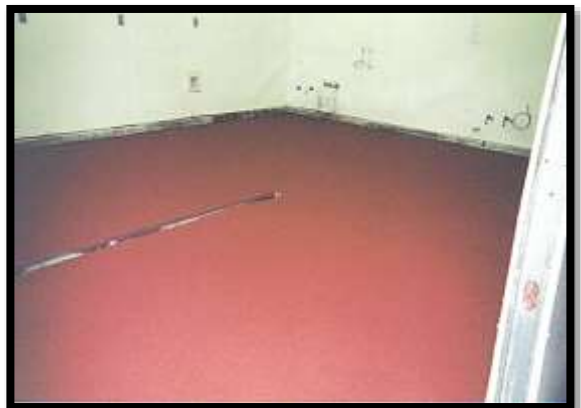
A major Pork Processing company was experiencing concrete damage from the animal fats and cleaning chemicals in a 1,300 ft.² (130 m²) area. In addition, the floor had no pitch to the trench, which caused a standing water problem. This accelerated the deterioration on the concrete and caused concern from the U. S. D. A.

Water now flows to the trench, which has eliminated the concern for bacterial growth. The **3300 FS** has experienced no chemical deterioration in over 8 years of service.

The floor was de-greased and mechanically prepped to remove any loose concrete and to provide the proper bonding profile. Epoxy primer was applied to the surface and floor was pitched with **3500 Grout** epoxy grout and allowed to cure. Surface was then re-primed and **3300 FS** epoxy mortar was troweled at a thickness of ¼" (6 mm). Project was completed in two days.
