## Case History – BNE Iron Guard Installation - GoldCorp

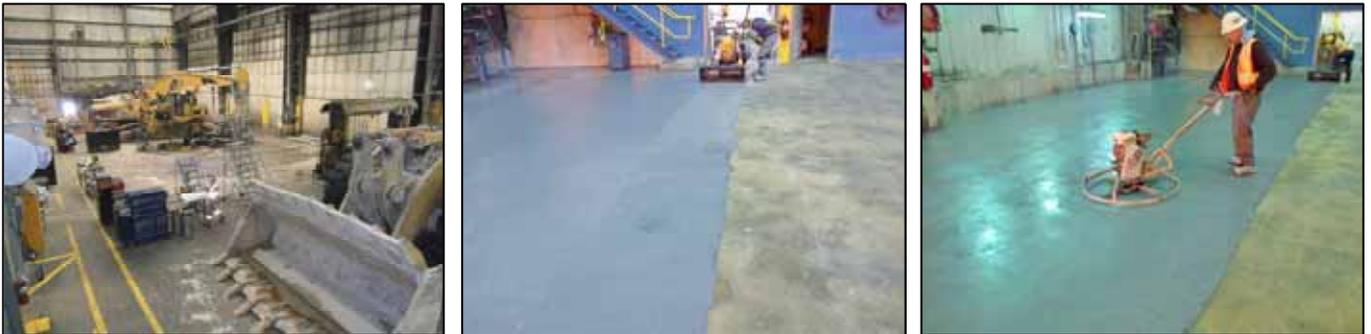
The floor in their Vehicle Maintenance Shop was heavily pitted because of the enormous amount of heavy wear and abuse it sees. In this area they maintain mining equipment and their fleet of trucks that can weigh more than 225,000 lbs. Their mechanics were having difficulty rolling their toolboxes over the uneven surface safely and using their roller carts to get under the vehicles and equipment. Several times the concrete was removed and replaced and a metallic shake hardener was tried without success. These options were very expensive and required extensive downtime for the concrete & toppings to cure enough for heavy use.

The 12,000 sq/ft area was divided into two 6,000 sq/ft sections so GoldCorp could continue their maintenance operations during installation. BNE ground the rough areas to remove loose, old concrete and toppings. Then they shotblast the area to remove oil and containments and provide a good profile for the epoxy to bond. All drains and entrances to the shop were keyed approximately a 1/2". After the floor was prepped the area was primed with deep penetrating ICO Primer LV at 200 sq/ft per gallon and silica sand was broadcast into the primer to provide a good bite while power troweling. The Primer LV was allowed to cure overnight and the Iron Guard was power troweled in 6-7 hours for a single lift at a 1/2" nominal thickness. Each section took three days to prep, prime, power trowel, and install safety lines. They client was able to return the floor to service 24 hours after installation.
