Case Study: Firehouse Floor

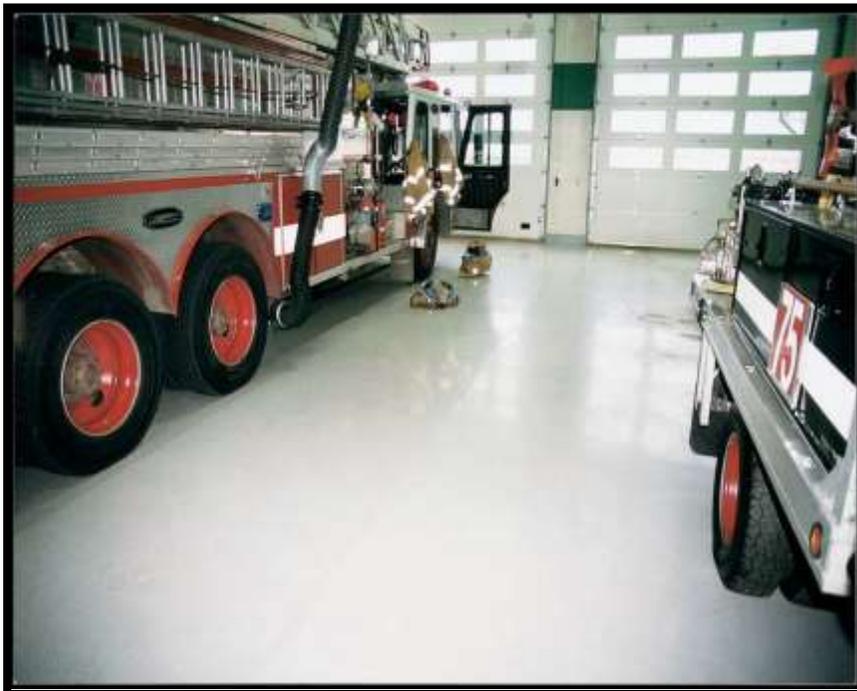
Fire officials were very pleased with the results. Because the 100% solids epoxies had very little odor, operations were not disrupted during application. More importantly, the floor has held up well for over three years without any need for recoating. While some gouging has occurred, the greater thickness has prevented penetration all the way thru to the concrete. Maintenance has been easily accomplished by damp mopping and occasional solvent wiping of grease and oil.

Because the firehouse had to be kept in operation readiness, the floor was done in two sections. After removing the old coating and getting down to bare, clean concrete, the applicator applied a thin coat of Primer LVFC, followed a few hours later by application of the Floor SL. The half floor was returned to service after a total downtime of 48 hours, including prep, application and cure. The second half was completed the following weekend in a similar fashion.
