Case Study: Coldcorp Gold Producers

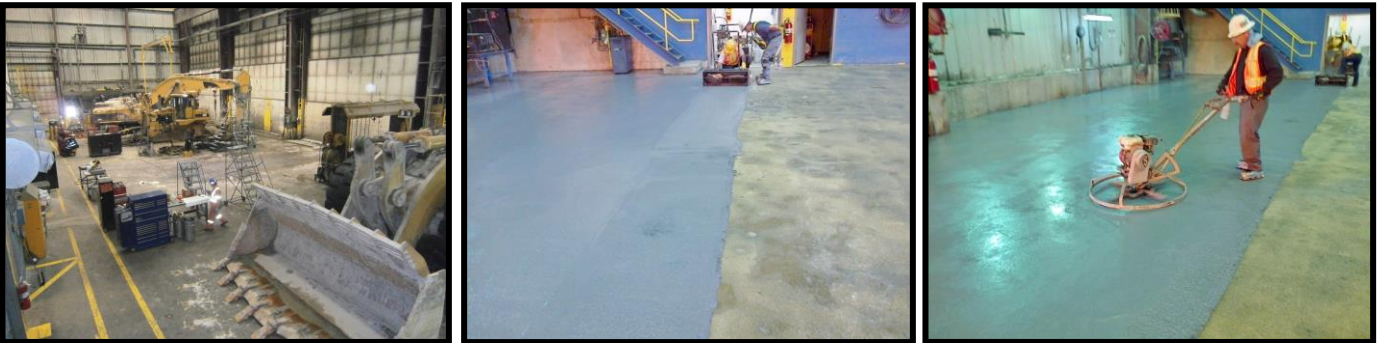
The floor in their Vehicle Maintenance Shop was heavily pitted because of the enormous amount of heavy wear and abuse it sees. In this area they maintain mining equipment and their fleet of trucks that can weigh more than 225,000 lbs. Their mechanics were having difficulty rolling their toolboxes over the uneven surface safely and using their roller carts to get under the vehicles and equipment. Several times the concrete was removed and replaced and a metallic shake hardener was tried without success. These options were very expensive and required extensive downtime for the concrete & toppings to cure enough for heavy use.

GoldCorp General Foreman, Ray McIver was impressed by Milamar Contractor BNE's credentials and prior work history in similarly tough environments. Because of the conditions Chris Henderson of BNE recommended Milamar's ICO Iron Guard, a three part, steel reinforced epoxy system intended for unusually severe wear applications, applied at a 1/2" thickness. With its non-rusting, proprietary steel fill, it has tremendous abrasion and impact resistance. ICO Iron Guard also had the fastest turnaround time of all the alternatives. Applied in a single pass it cures hard for truck traffic in 28 hours at 70F, greatly reducing Goldcorp's downtimes. In addition it is a seamless system that can withstand the penetration of oils, salts, and liquids.

The 12,000 sq./ft. area was divided into two 6,000 sq./ft. sections so GoldCorp could continue their maintenance operations during installation. BNE ground the rough areas to remove loose, old concrete and toppings. Then they shotblast the area to remove oil and containments and provide a good profile for the epoxy to bond. All drains and entrances to the shop were keyed approximately a 1/2". After the floor was prepped the area was primed with deep penetrating ICO Primer LV at 200 sq./ft. per gallon and silica sand was broadcast into the primer to provide a good bite while power troweling. The Primer LV was allowed to cure overnight and the Iron Guard was power troweled in 6-7 hours for a single lift at a 1/2" nominal thickness. Each section took three days to prep, prime, power trowel, and install safety lines. They client was able to return the floor to service 24 hours after installation.

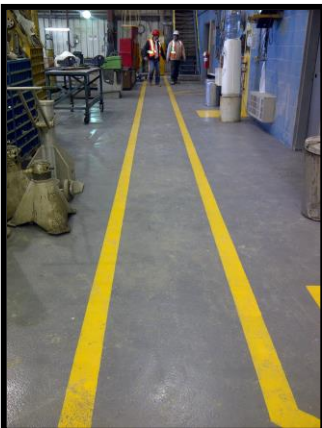
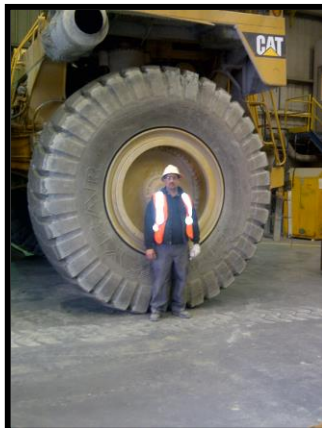
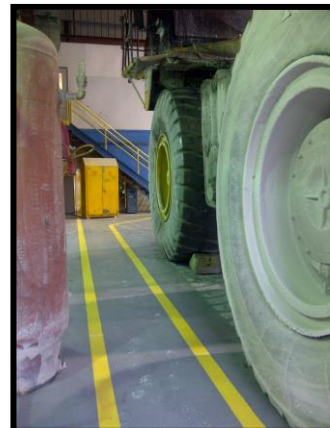
Despite being somewhat skeptical as they had used other repair products in the past, GoldCorp is very impressed with their new floor. It has been performing exceptionally well and has not shown the early signs of wear as the other products had.
