Case Study: Pickle Brine Room

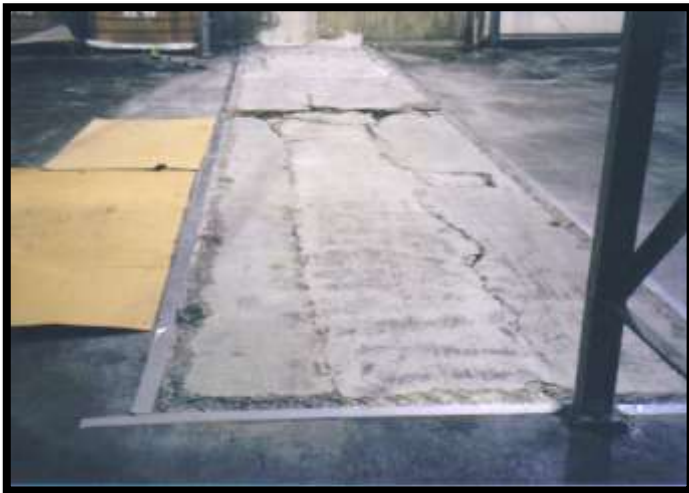
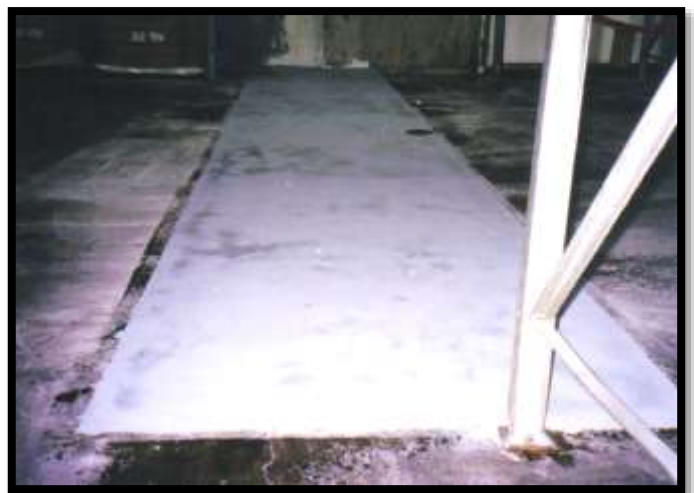
A pickle processing company experienced severe damage from vinegar and forklift traffic. The years of mechanical and chemical abuse caused spalling and cracking in the concrete.

The damaged area was isolated by saw cutting and keying edges. Concrete was scarified to remove contaminants and to provide the proper bonding profile. Severely damaged areas were primed with epoxy primer and pre-filled with Milamar's 3300 FS. Entire area was then primed and resurfaced with 3300 FS at a thickness of $\frac{1}{4}$ " (6 mm). Project was completed in one day. The repaired area has shown no sign of chemical attack and only normal wear from forklift traffic in eight years of service.
