Case Study: Goldcorp Gold Producers

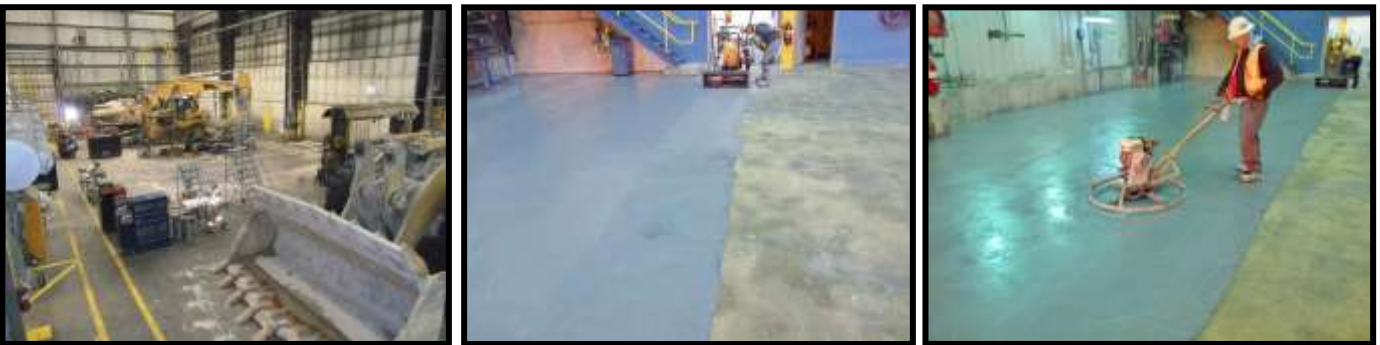
The floor in their Vehicle Maintenance Shop was heavily pitted because of the enormous amount of heavy wear and abuse it sees. In this area they maintain mining equipment and their fleet of trucks that can weigh more than 225,000 lbs. Their mechanics were having difficulty rolling their toolboxes over the uneven surface safely and using their roller carts to get under the vehicles and equipment. Several times the concrete was removed and replaced and a metallic shake hardener was tried without success. These options were very expensive and required extensive downtime for the concrete & toppings to cure enough for heavy use.

GoldCorp General Foreman, Ray McIver was impressed by Milamar Contractor BNE's credentials and prior work history in similarly tough environments. Because of the conditions Chris Henderson of BNE recommended Milamar's ICO Iron Guard, a three part, steel reinforced epoxy system intended for unusually severe wear applications, applied at a 1/2" thickness. With its non-rusting, proprietary steel fill, it has tremendous abrasion and impact resistance. ICO Iron Guard also had the fastest turnaround time of all the alternatives. Applied in a single pass it cures hard for truck traffic in 28 hours at 70F, greatly reducing Goldcorp's downtimes. In addition it is a seamless system that can withstand the penetration of oils, salts, and liquids.

The 12,000 sq./ft. area was divided into two 6,000 sq./ft. sections so GoldCorp could continue their maintenance operations during installation. BNE ground the rough areas to remove loose, old concrete and toppings. Then they shotblast the area to remove oil and contaminants and provide a good profile for the epoxy to bond. All drains and entrances to the shop were keyed approximately a 1/2". After the floor was prepped the area was primed with deep penetrating ICO Primer LV at 200 sq./ft. per gallon and silica sand was broadcast into the primer to provide a good bite while power troweling. The Primer LV was allowed to cure overnight and the Iron Guard was power troweled in 6-7 hours for a single lift at a 1/2" nominal thickness. Each section took three days to prep, prime, power trowel, and install safety lines. They client was able to return the floor to service 24 hours after installation.

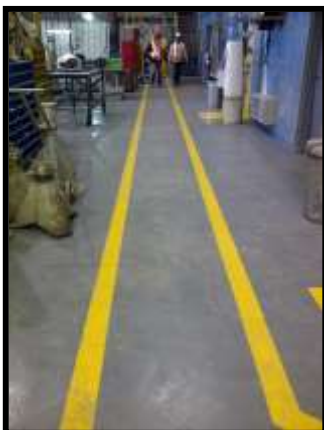
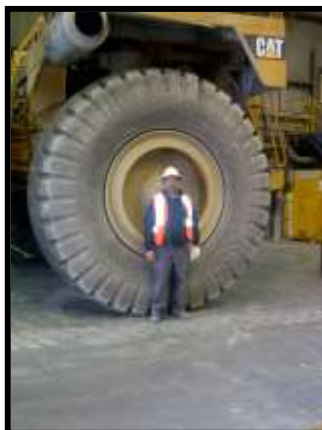
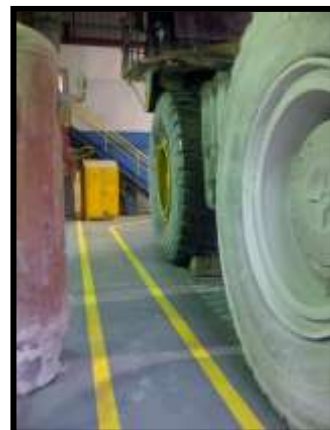
Despite being somewhat skeptical as they had used other repair products in the past, GoldCorp is very impressed with their new floor. It has been performing exceptionally well and has not shown the early signs of wear as the other products had.
