Coatings Crew Talks Turkey

White meat or dark meat is usually the question when it comes to turkey, but it could have been no meat if the facility up-grade at the Colorado processing plant didn't run smoothly. The ConAgra plant in Longmont, Colorado not only processes turkeys, but also packages them for direct retail consumption. A booming business meant that they needed to modernize their facility — in particular a much utilized 5,000 square foot (464.52m²) cooler/food processing room. But the booming business also meant that the plant could not close during construction. It was time to "talk turkey," as it were, and figure out a plan.

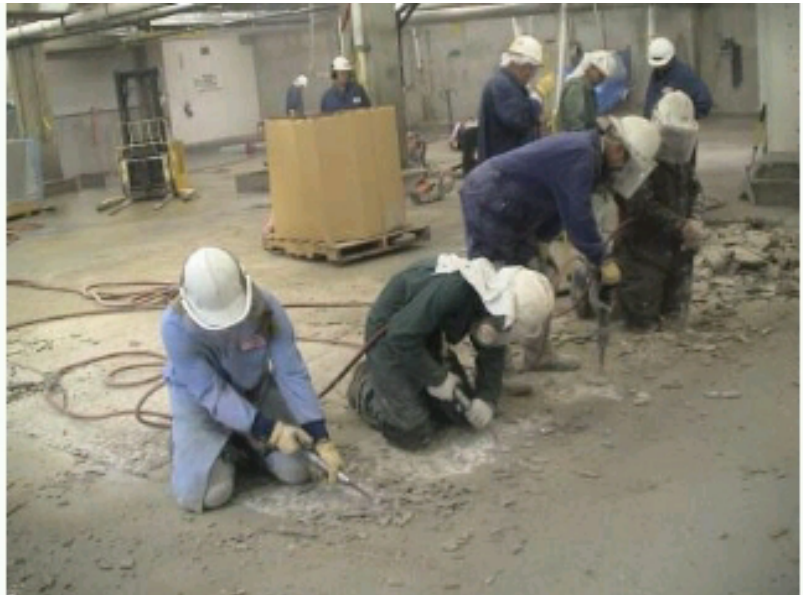
"We attacked the ceiling first," Behunin remembers. The uncoated T-panel concrete was extensively damaged. "We had to mechanically grind and sandblast the concrete to achieve a clean, abraded surface profile. We basically brought the concrete to the NACE No. 3/SSPC-SP 6 Commercial Blast standard using Black Beauty slag."

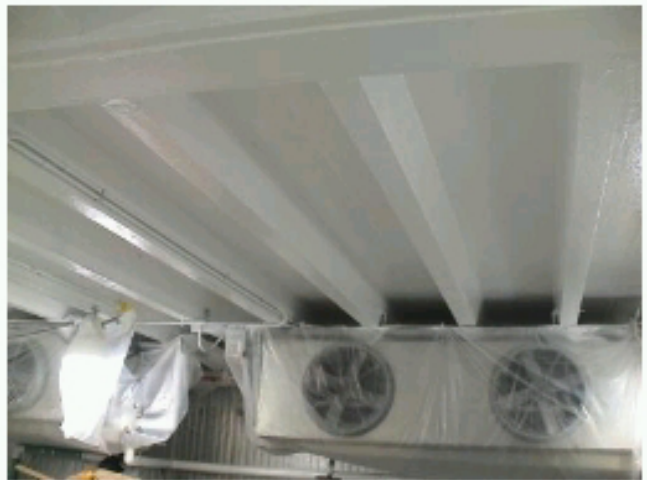
With the bio-hazards removed, the crew used trowels to apply International Coatings' epoxy filler, ICO Gel, into the many bugholes throughout the ceiling. Behunin states: "After the ICO Gel had cured, we used our Graco Bulldog to spray two coats of ICO Glaze Base Coat at 12 to 14 wet mils (0.30mm-0.36mm) each, backrolling to ensure coverage. This was followed by one, 10 to 15 wet mil (0.25mm-0.38mm) top coat of ICO Glaze Top Coat." The ICO Glaze Top Coat is a high gloss, 100% solids, epoxy that is designed to provide a complete vapor barrier able to withstand the cooling room's constant damp and sanitizing chemicals.

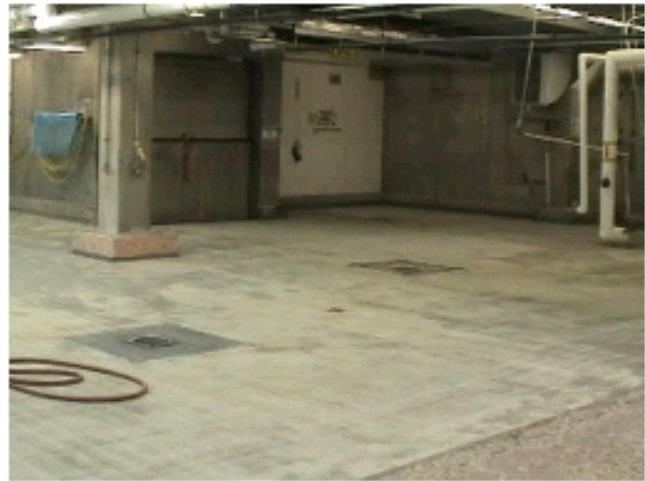
He continues, "Any open cracks were routed to 1" (2.54cm) wide and 1" (2.54cm) deep and filled with the ICO Guard 51 epoxy. We also filled any holes—such as old drains or anything over 2" (5.08cm) deep with epoxy prior to coating the floor, so that when we install the coating, it doesn't collapse into the holes." They also cut and filled keyways around all drain plates and at the entryway to the room. When the epoxy had cured, the floor was washed with hot water.

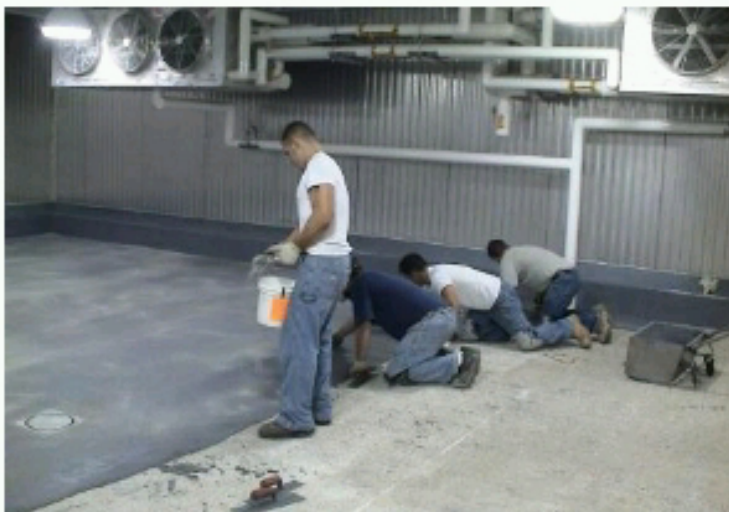
Dry and prepped, the floor was ready to be coated. Behunin and his crew first warmed the International Coatings' ICO Guard 51 epoxy to 85°F to 95°F (29°C-35°C), mixing the three-part epoxy in a mortar mixer. Then armed with trowels, they began applying the resin-rich, 100% solids epoxy in a single 3" to 4" (7.62cm-10.16cm) application, sloping some areas to drain. "We hand-broadcast 20-grit sand to excess into the wet material to create a non-skid surface," Behunin says. "No topcoats were necessary because we broadcast the aggregate directly into the coating."

"While the floor was being installed, we also installed new trench drains, using the epoxy to fill in between the new floor and the drain to create a permanent, watertight bond."
