Case Study: Bakery Staging Area

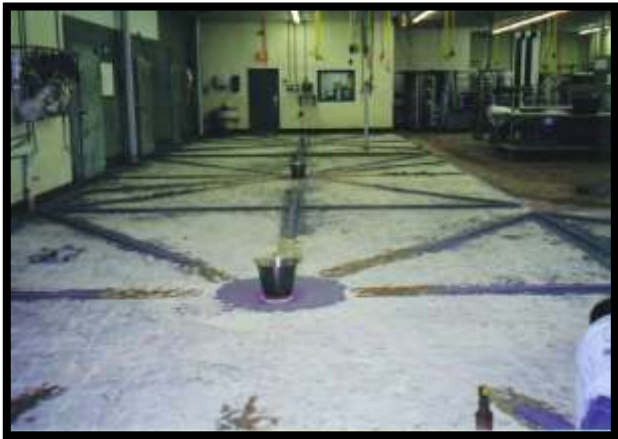
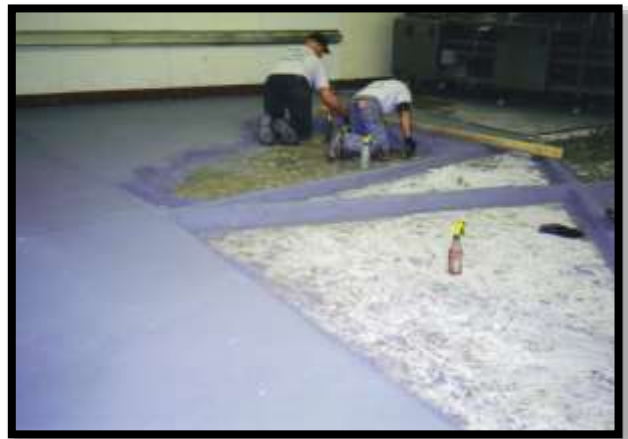
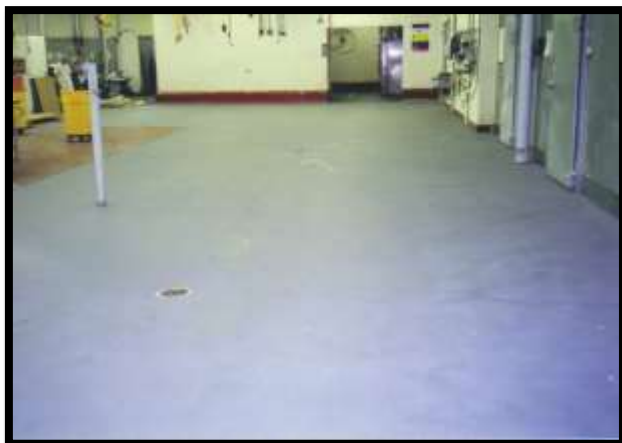
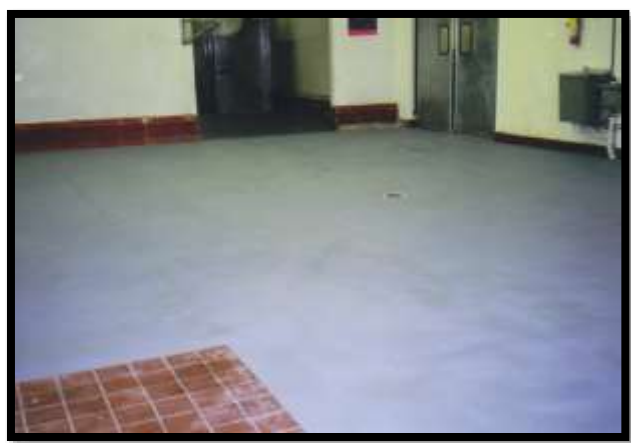
A major Midwest baking company had a large section of tile floor fail from years of forklift traffic and chemical wash downs. The grout between the tiles eroded which allowed caustic solutions to attack the grout bed below the tile.

Tile and grout bed was removed down to clean, sound concrete. Since the floor pitch was established with the grout bed, the floor had to be re-pitched with Milamar's 3500 Grout epoxy grout. The thickness of the 3500 Grout ranged from 6" (152 mm) down to ¼" (6 mm). 3300 FS was then troweled over the entire surface at a thickness of ¼" (6 mm).

The combination of the 3500 Grout and 3300 FS has held up for 6 years without any problems from chemical attack or forklift traffic. The pitch to the drains that was established has kept water flowing to the drains. The 2,800 ft.² (280 m²) project was completed in four days.
