Case Study: Bleach Plant

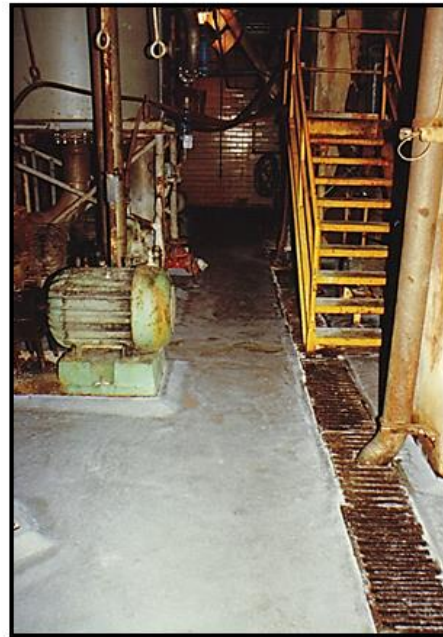
After

Areas of a pulp & paper bleach plant floor and pump bases were suffering severe erosion from calcium hypochlorite, caustic, and sulphuric acid. Trenches had been cut by the chemical attack, and in some areas the concrete was reduced to loose gravel. 5500 Grout was used to fill eroded areas, and correct the pitch of the floor. 6000 VS was installed to rebuild vertical surfaces of pump bases that had eroded. 6000 FS was then applied to the floor. The 6000 Series provides a seamless, non-porous surface that resists attack from the severe conditions in the bleach plant.
