## Case Study: Canadian Tire

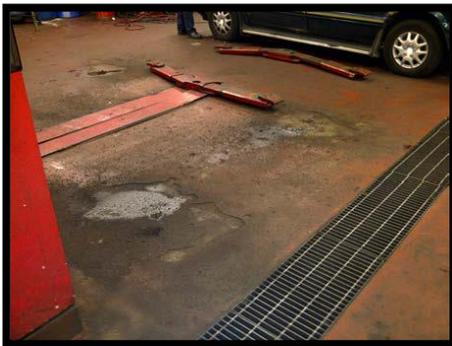
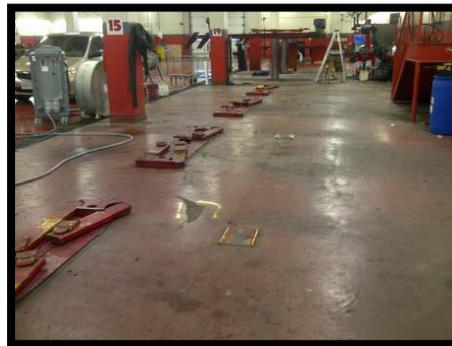
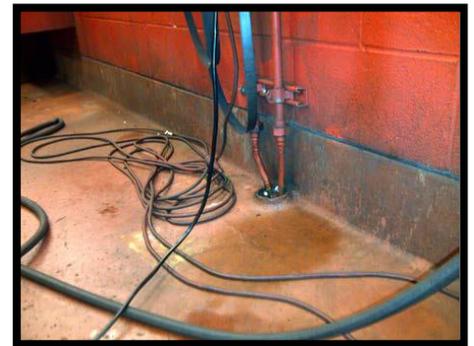
The current floor was dirty, pitted and worn over the years by the constant traffic, brake fluid, and impact from dropped tools. The existing coating was too porous (a dry mix with too much sand for the amount of resin) and did not have the chemical resistance required. Barry Hinds, of Canadian Tire, was looking for a floor coating that had better chemical and impact resistance, provided a good aesthetic, and could be applied with a minimal amount of inconvenience to their customers.

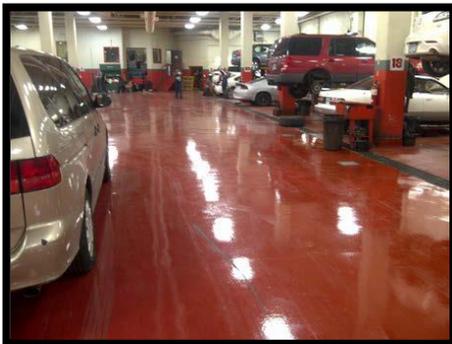
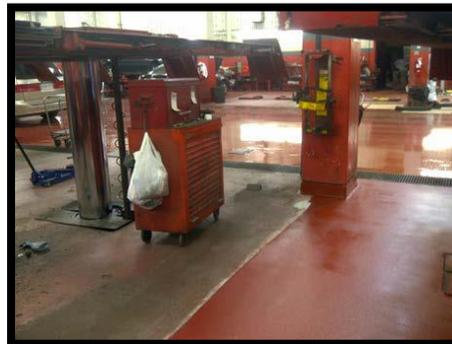
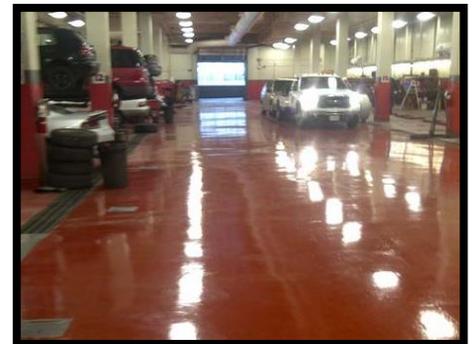
The project was split into three phases, the two hoist bay areas and the center aisle. Both bays were prepped using planetary grinders and hand planers. In one of the service bay areas, 2,000 sq. ft. of the old coating had to be removed and BNE hand trowelled ICO Floor 51 to a 1/4" thickness. ICO Floor 51 is tough and durable, resin rich, system that goes down in a single step. Then both bays were coated with ICO Primer XT at 200 sq. ft. per gallon and a full broadcast of 32 mesh silica sand. This system has excellent adhesion and the addition of silica sand builds it up for greater impact resistance. Finally the entire facility including the center aisle was top coated with ICO Ure Guard 80. This urethane topcoat was chosen because of its UV stability, gloss retention, resistance to brake fluid and it does not stain from tire exposure unlike many urethanes.
