Case Study: Enterprise Transport

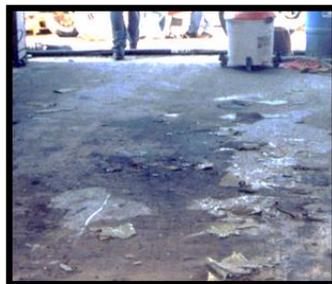
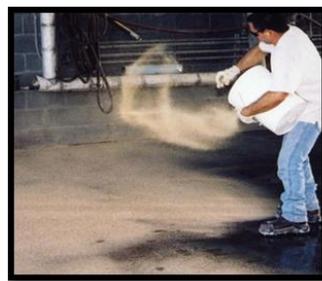
Bruce Parker, Director of Maintenance and Mike Leggio Terminal Manager of the Gulfport, TX terminal were experiencing failure with their current floor coating after only two years and the walls of the sump for the trench drain had collapsed. They were also concerned for the safety of their employees because the floor had very little traction and would get slippery when wet. The trucks are washed with a cleaner, which is determined by what they are carrying and then rinsed with hot water inside and out. The strong cleaners as well as corrosive materials hauled in the trucks in combination with the abrasion from the dirt and gravel tracked in from the parking lot were attacking their floors. The current coating was too thin and was not installed properly for the conditions. They had met Bert Downing of Milamar Coatings when he spoke at the Assoc. of Haulers national convention and decided to give him a call.

Bert brought in Tom Burk and Rick Jones of Plant Maintenance Services, certified contractors out of Houston, TX to help fix the problems. The first step was to thoroughly remove the old coating and clean the floor; this was done with a combination grinding, pressure washing and shot blasting. All joints and cracks were routed out to remove failing joint fillers and coatings then they were saw cut.

Outside perimeter edges were saw cut and keyed. The wall that had collapsed was removed and a fiberglass sump was prefabricated by the contractor then set in place. The top edge flange was sealed with ICO-Hi Guard and reinforced with fiberglass fabric. After all detail work was done a coat of ICO-Primer LV was applied and allowed to dry tack free. Then dark gray ICO- Hi Guard was applied using a slurry/broadcast method to achieve a ¼" total thickness. ICO- High Guard was chosen because of its excellent chemical resistance and ability to stand up to thermal and mechanical shock. The job was done over two weekends with each session starting Friday evening and ending Sunday afternoon with traffic resuming first thing Monday morning. The end result was exactly what Bruce and Mike were looking for - a durable floor that could withstand the harsh conditions and remain safe for their employees to walk on when wet.
