Case Study: Mercedes Benz Dealership

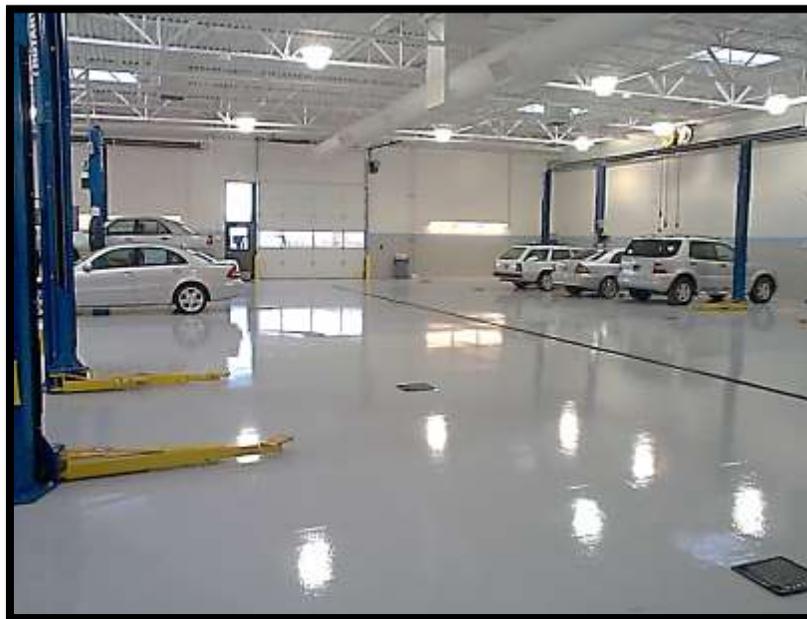
The dealership has been open over a year now and so far the floor system has exceeded expectations. The owners and Mercedes have themselves a very, high-tech, upscale look in keeping with their demography, and the service and maintenance people have a very easy-to-clean and light reflective floor that has dramatically enhanced working conditions, compared to previous shop floors. Service personnel have reported how well the floor resists gouging and nicks from dropped tools. Mercedes officials are keeping a close eye on things and hopefully, given continued satisfaction, will incorporate these floor specs into a nationwide upgrade of their dealership's service centers.

CDC, a long-time certified contractor of Milamar Coatings, decided that use of our flexibilized epoxy coating, **ICO Floor Coating**, in combination with a two-part aliphatic urethane top coat would provide the customer with the best bang for the buck. Working together, CDC and Milamar came up with a four-step system to ensure the longest life: one coat of **ICO Primer LV**, a base coat of **ICO Floor Coating** at 10 mils, a top coat of **Ure Guard 60** aliphatic urethane, pigmented, and finally a top coat of clear **UreGuard 60** for hiding scratches and dirt. In the car wash areas, a heavier 60-mil liquid/aggregate system utilizing **ICO Floor Coating** was used. The floor was shotblasted, cracks were filled, and then the four-coat system was applied.
