## Case Study: Ste. Michelle Winery

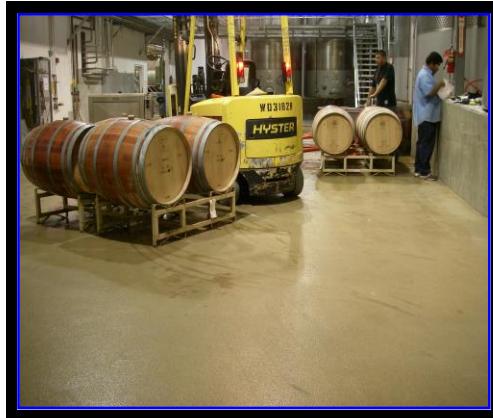
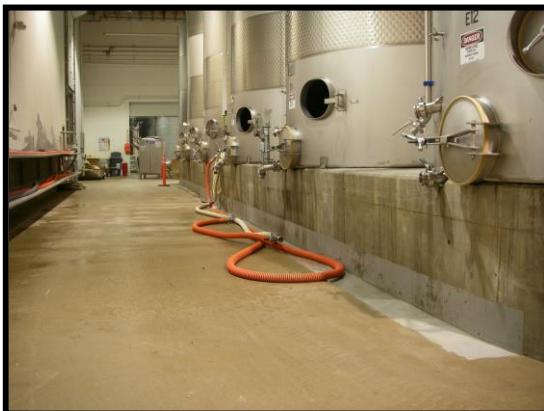
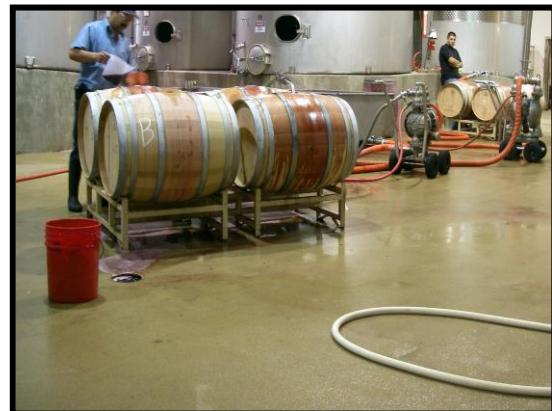
Ste. Michelle Winery also did not want an "industrial" look so Baldy recommended using local, light brown "Monterey Sand" and clear resin to provide a decorative, more natural look.

Coatings Unlimited first prepped the concrete by removing any existing coatings and getting a clean sound substrate so the epoxy could bond properly. They then mixed the resin and sand at ratio of 1 to 1 by volume. The slurry was then poured on the floor and trowelled to a smooth surface. Next they broadcast an equal amount of sand as used in the slurry until refusal. A squeegee coat of resin was then applied and broadcast into it again for a more uniform even look. Lastly after removing any loose sand and vacuuming the surface they applied a topcoat of the clear ICO Floor resin to get the desired finished texture.

The floor has been down for years now and Ste. Michelle Wine Estates is very pleased with the performance of the floor and plan on having Coatings Unlimited do more work in the future.
