## Case Study: Yuma Dairy Milking Parlor

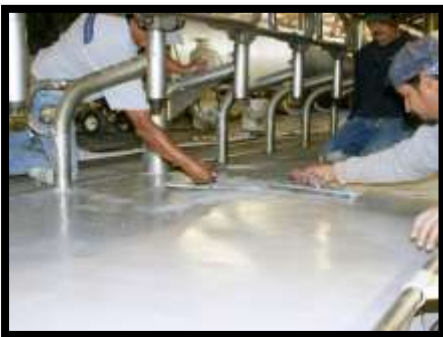
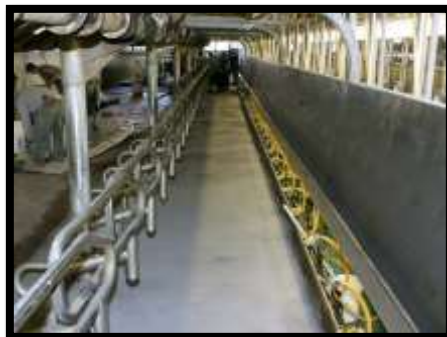
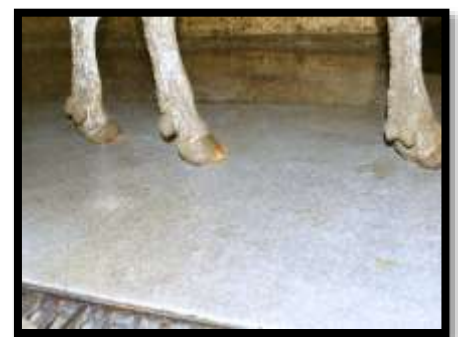
There is tremendous wear and tear on the concrete cow decks by these 1800lb cows in these types of facilities. During the milking operation, the cow rocks back and forth over the same area of the cow deck about a square foot in size. This constant shuffling and impact causes the concrete to wear in deep pockets which fill with waste and wash water. Standing in these puddles is uncomfortable and causes more shifting of weight and the cycle continues, creating deeper holes and eventually tripping or twisting hazards for the animal. Combine this with the need to maintain sanitary conditions as regulated by the State Health Dept. and USDA, and provide a safe and slip-resistant environment for the animal, and you have a very challenging environment indeed. Yuma Dairy needed a protective topping that would keep their cow's safe and comfortable, hold up to the physical challenges, as well as the standard sanitizing chemicals, lactic acid, and hot water wash down several times an hour, and most importantly, one which can be installed in a timely manner with minimum down-time

They first diamond grind the entire area followed by jack hammers to chase all cracks and remove any and all loose concrete. Then it's followed by a hot water wash down, sanitizing and degreasing chemicals, final rinse and removal of all standing water. The final step is a drying/sanitizing burn off with weed burner open flame and air as needed. The Iron-Guard™ topping is applied using a combination of hand-troweling and mechanical screed techniques to maintain thickness and slope to drain requirements. Then a broadcast of white aluminum oxide is added for enhanced traction. Project preparation is started in the early morning hours and usually takes 2-3 hours to complete. Iron-Guard™ is then mixed and applied. With an application crew of four plus two helpers, and one mixer, the entire job is usually completed in 3 hours at

They decided to specify Milamar Coating's ICO Iron-Guard™ (in the fast cure version for this project) as it has the needed physical wear properties, critical cure times, and can hold up to the constant wash-down regimen. Iron-Guard™ is an extremely tough system with special non-rusting steel fillers for superior wear resistance. Moreover, due to the extreme time constraints for floor preparation and application of the 1/4" nominal top-coat, the project demanded a system that had great damp adhesion, did not require priming nor pre-filling of cracks or deep depressions, and would finish in any thickness (100% solids) in a one-step process and be back in service 8 hours after application.

which time it is allowed to cure for a minimum 8 hours (at 70-75 degrees) before allowing sanitation crews to prepare the area and open up for milking.
