Case Study: Stock Storage Tower

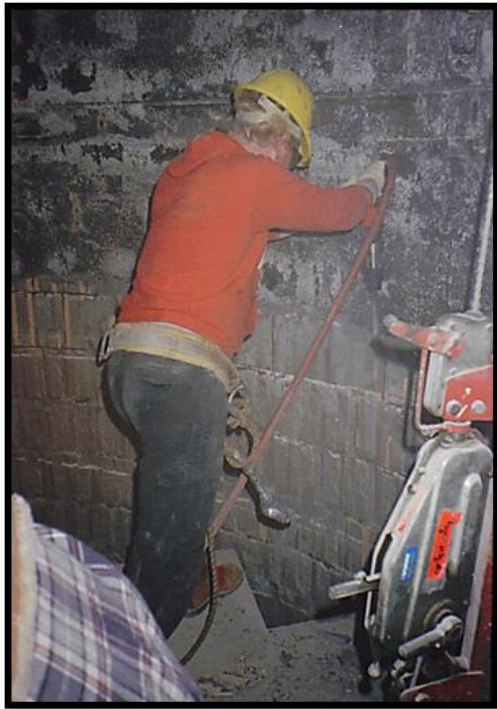
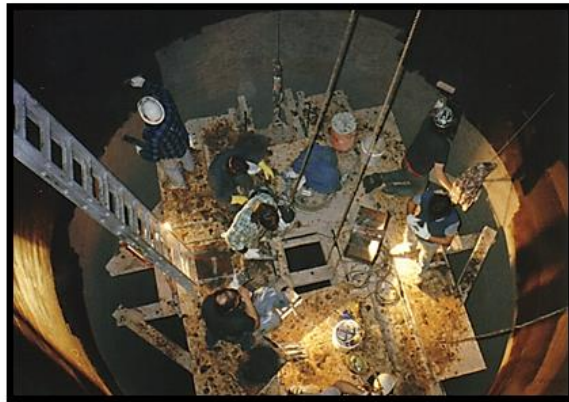
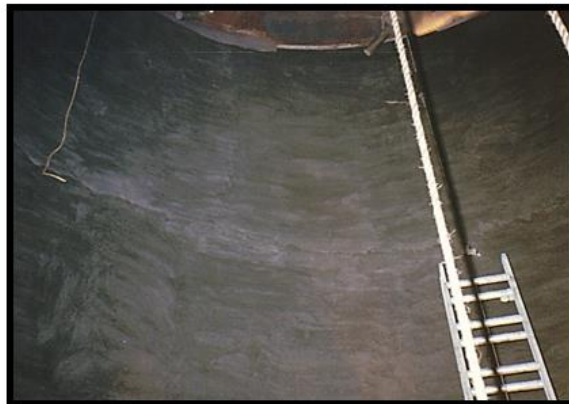
A High Density Stock Storage Tank had grout spalling around and behind tile lining. The tile was also loose in several areas. Because of grout porosity, the mill was concerned with corrosion of the carbon steel vessel. Suspend scaffolding from above and remove all the tile and grout. The metal was then sandblasted and 2600 Liner was applied. The Carbon steel tank is protected from corrosion by the 2600 Liner, leaving a smooth, seamless finish.
