Case Study: Bacon Press Line

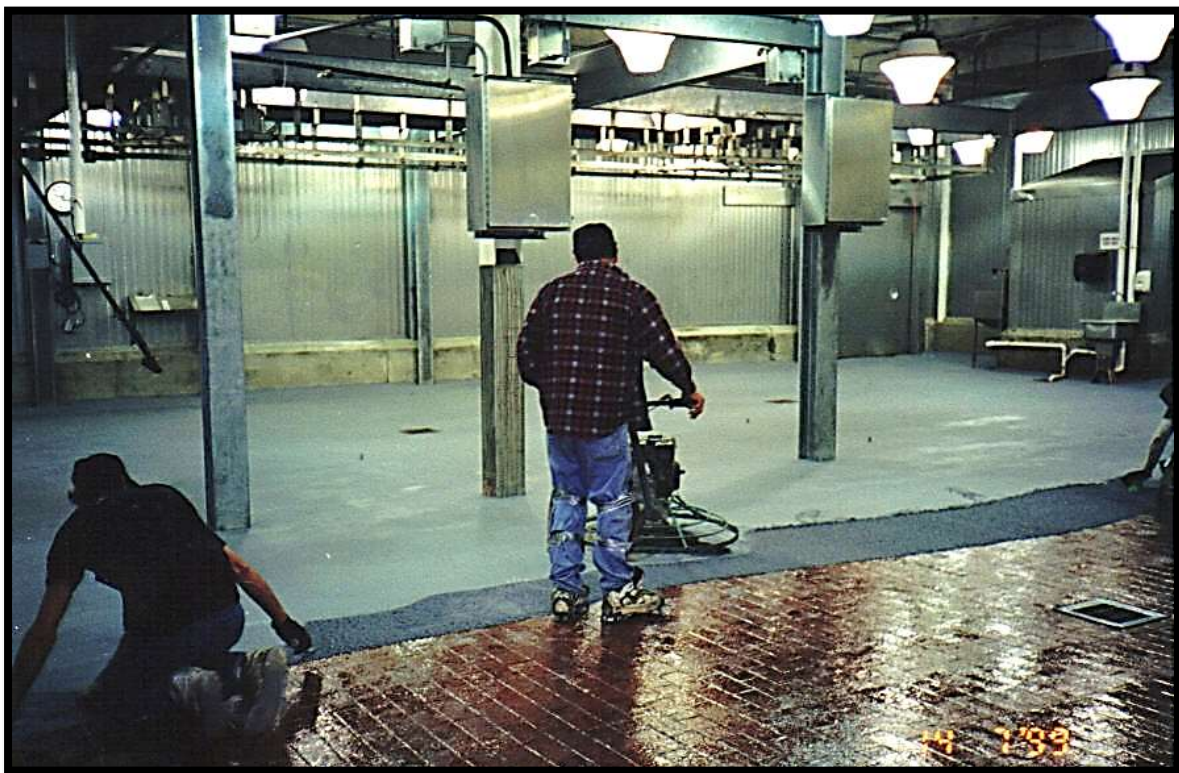
A major pork processor experienced problems with the tile floor. The tile floor became extremely slippery from animal fats. In addition, some of the individual tiles were loose or had delaminated and became a maintenance issue.

All of the processing equipment was removed. Tile was sound checked for loose tile. Loose and questionable tile were removed down to clean, sound substrate. Entire floor surface was degreased and shotblasted. Voids where tile had been removed were pre-filled with Milamar's 3300FS. Epoxy primer was then applied to surface and 3300FS was troweled at a thickness of $\frac{1}{4}$ " (6 mm). The 2,900 ft.² (290 m²) project was completed in two days.

The power troweled surface of the 3300FS provided a slip resistant surface that was still easy to clean. The surface has shown no attack from the fats and caustic wash downs in six years of service.
