Case Study: Electro Plating in Chemical Storage Area

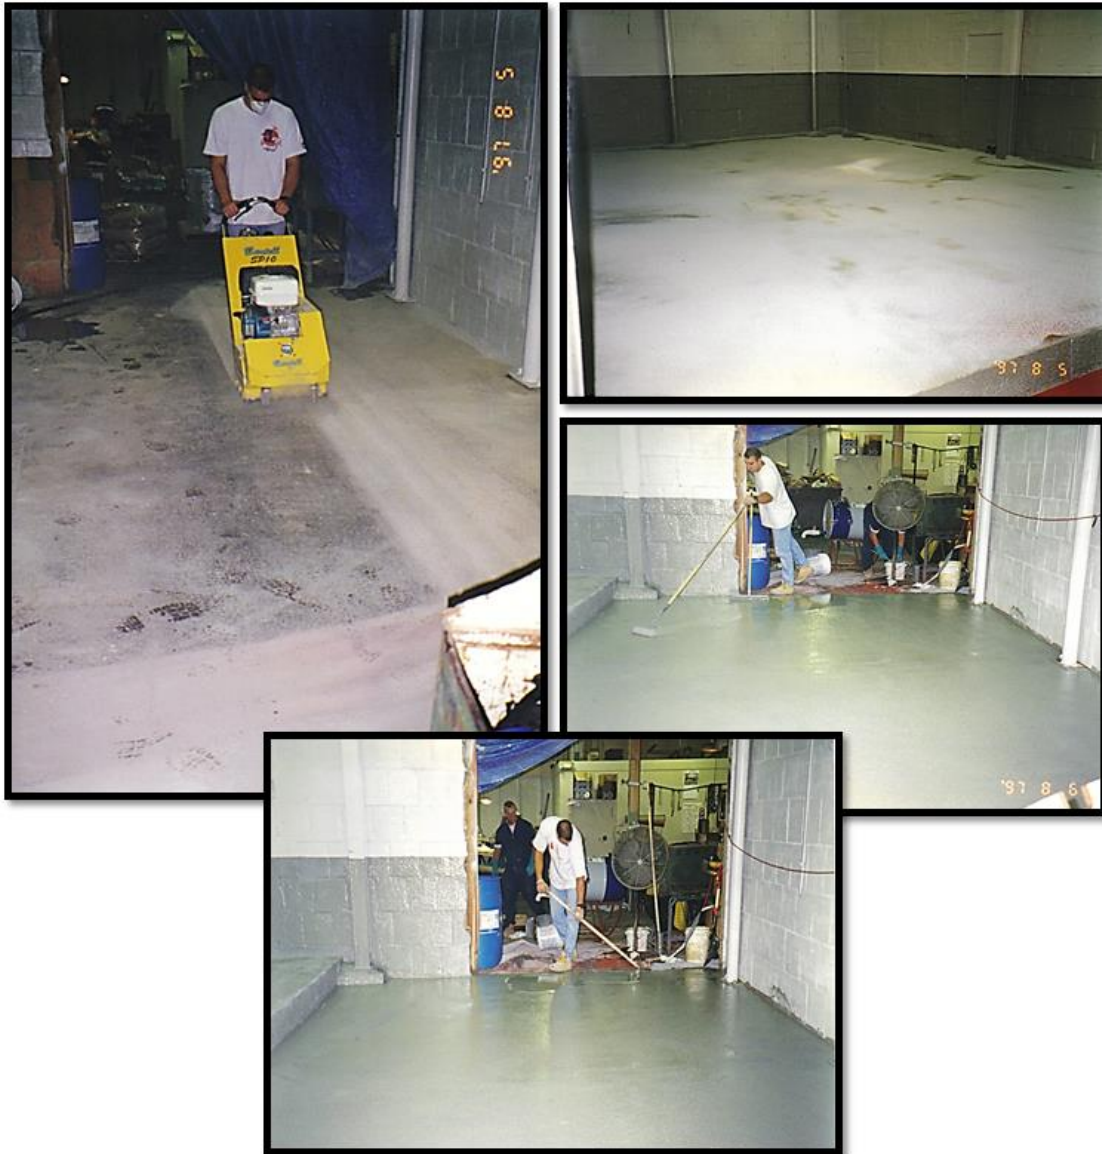
A plating company in the Northeast USA was experiencing chemical attack to the concrete floor in their chemical drum storage area. The floor was scarified to remove surface contaminants and to provide the proper bonding profile. Milamar's 6000 FS was installed at a thickness of $\frac{1}{8}$ " (6mm). Wall surface was diamond ground and coated with two, 15 mil coats of 6650 CS. No chemical attack has occurred in over 7 years of service. In addition, the 6000 FS has held up to the mechanical abuse from the steel drums and totes.
