### Case Study: Food Processing Chemical Attacks

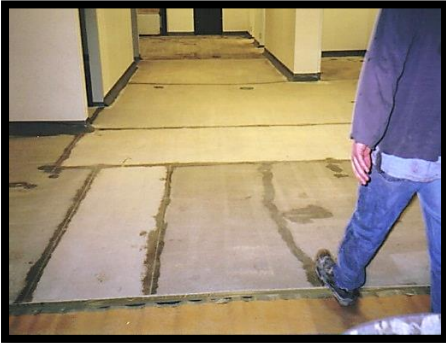
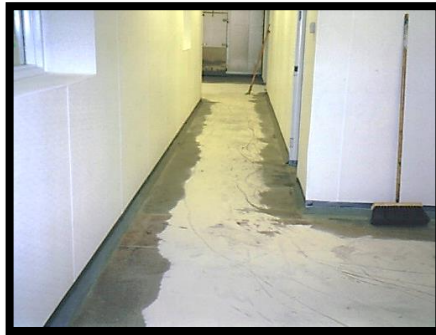
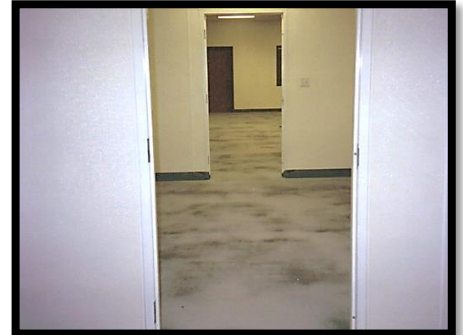
A meat processing facility was experiencing chemical attack from daily cleaning and pallet jack traffic. The concrete attack made daily sanitation more difficult due to the exposed aggregate. The concrete surface was shot blasted to remove surface contaminants and to provide the proper bonding profile. A 2", 45° cove was installed using **3300 FS** epoxy mortar. **3100 FS** was applied to the surface at a thickness of 1/8" (3 mm) and sealed with **1000 CS**.

The installation provided a durable surface with a non-slip texture. Chemical attack from the cleaning solutions was eliminated and actually reduced cleaning costs by reducing the time required to clean the area.
