### Case Study: Meat Processing Food Plant

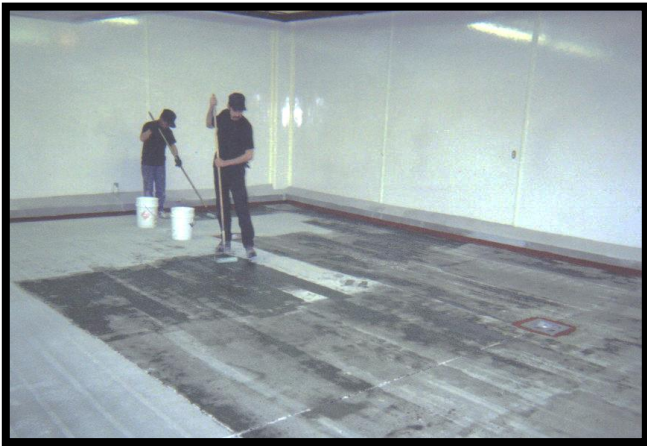
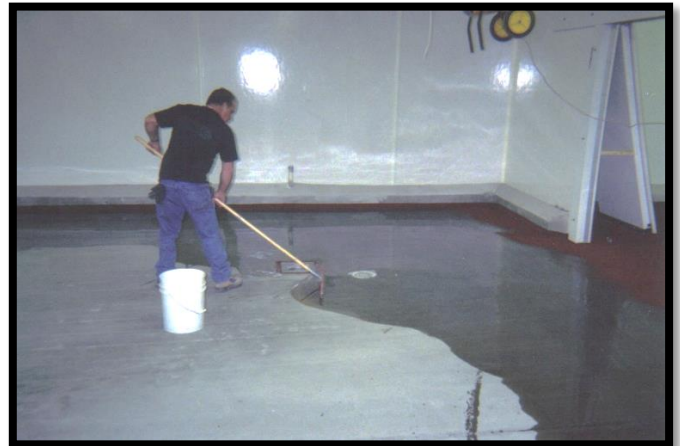
**6000 FS** was installed at  $\frac{1}{4}$ " (6mm) over entire processing, cooler and freezer areas to form a monolithic surface with a non-slip surface. The 6,000 ft.<sup>2</sup> (600 m<sup>2</sup>) project was completed in 3 days. The vinyl ester floor system has prevented any chemical attack for the four years of service. The **6000 FS** has also withstood the abuse normally experienced from heavy forklift traffic.
