Case Study: Newmont Goldmine

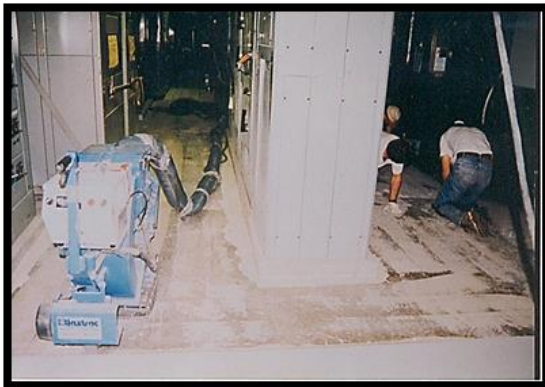
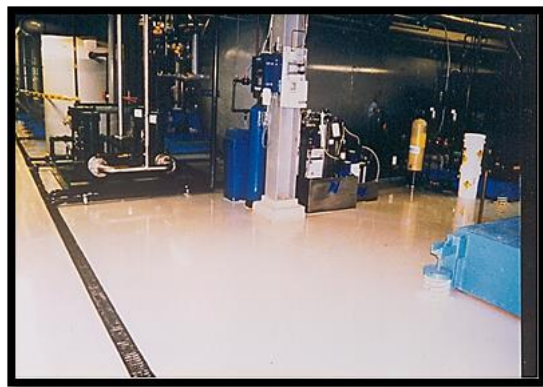
Gold mines present a particularly corrosive environment with constant usage of 98% sulfuric acid, together with infrequent wash-downs. In addition, the areas are subjected to extremely heavy forklift traffic. Severe erosion was present in both vertical and horizontal surfaces, in some cases up to 2" deep. To compound the problem, time constraints were very severe, due to continuous mine production, with downtimes limited to no more than 72 hours.

Floors and walls were sandblasted to remove all degraded concrete and provide a sufficient profile. The surfaces were then primed with ICO Primer LV. Since much more material was removed on the vertical surfaces than expected, the Hi Guard Liner had to be thickened up with silica flour, which enabled application of the liner up to 1/2" thick in certain areas. Similarly, the Hi Guard flooring material was applied in a single pass up to 2" thick. The ability to apply both products in a single pass enabled the area to be returned to service within the allotted time of 48 hours.
