## Case Study: Shower Coating System

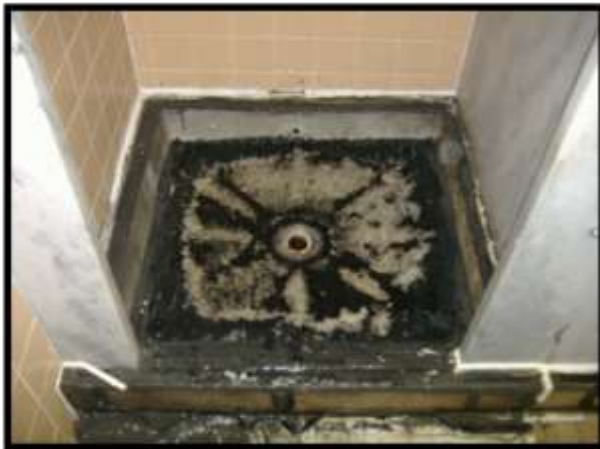
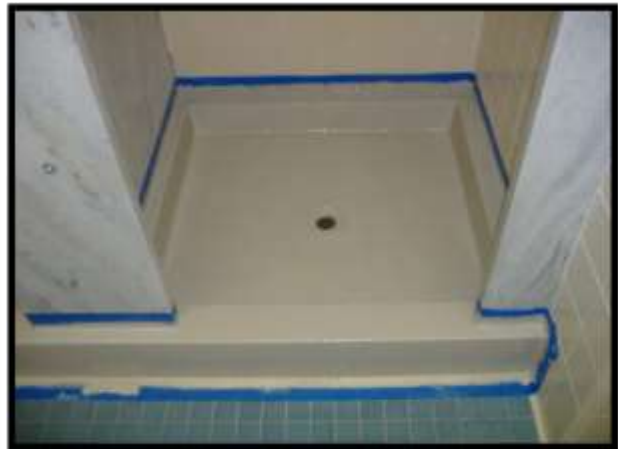
Another common issue Mike sees is where they tried to use acrylic pans over the original shower base to stop the leaking. The caulk sealing around the acrylic pan inevitably fails and moisture gets between it and the original shower pan. As you can see from the picture below mold and mildew become a serious issue. Constant re-caulking of the showers proved to be an expensive and short term answer. Mike's solution is to completely remove the acrylic pan, clean all the mold and mildew build-up, and grind the original shower pan. Next he fixes any cracks with ICO Gel and then primes with ICO Primer LV and applies two coats of ICO Glaze. This has proved to be a permanent solution that has saved his customers thousands of dollars in maintenance and repairs.

Mike first removes the soap scum and contaminates off the shower tile using a high pressure steam cleaning machine and a good soap scum remover. He then shot blasts the surface and removes any loose or damaged tile and repairs those areas with Milamar's ICO Gel. Next he primes with ICO Primer LV and then two coats of ICO Glaze.
