Case Study: South Dakota Air Guard Hanger

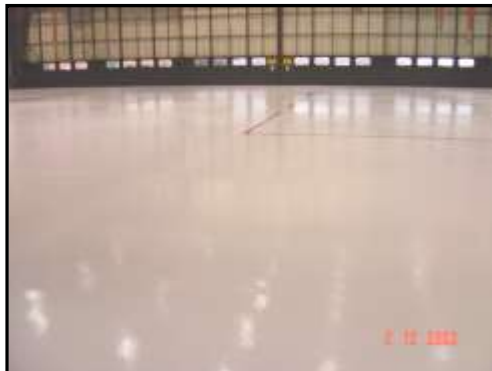
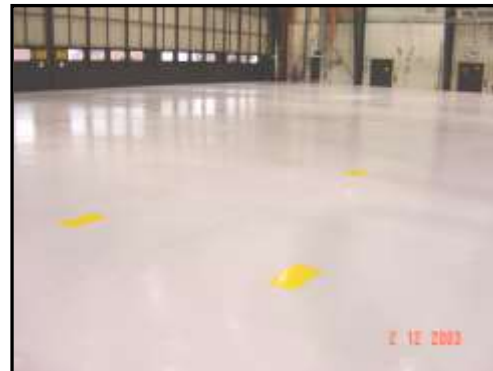
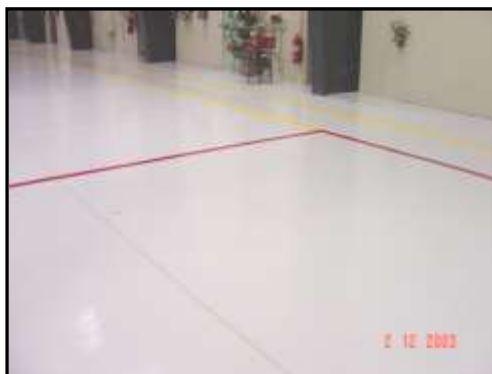
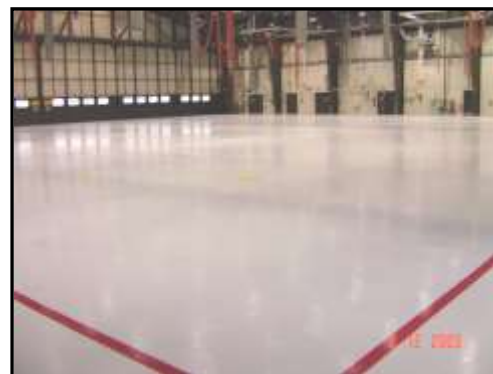
The South Dakota Air Guard's hanger floor in Sioux Falls had been previously coated on several occasions. As a result of poor surface prep the Guard was left with a very uneven floor that not only looked unsightly, but also made conveyance of equipment much more difficult. In addition to the floor additional needs included a high wearing safety striping material that could hold up to heavy loads and mechanical abrasion, as well as the filling of numerous expansion joints. Bumble Bee Construction out of Sioux Falls was asked for their proposal on how to solve the uneven floor problem and how to recoat the floor to obtain maximum life under a very tight budget.

Working with our area rep, Jerry Kron of CMI out of the Twin Cities, Jim Weixel of Bumble Bee came up with the following solution: 1. Using diamond grinders, the existing floor would be leveled and the old coating would be removed 2. A first coat of Milamar Coatings' flexibilized, 100% solids, two part epoxy coating, ICO Floor Coating, was applied at 10 mils 3. Two coats of a two part, aliphatic, UV-resistant urethane coating, ICO Ure Guard 60, were then applied at about 2-3 mils dry film thickness per coat 4. Safety striping in several colors was provided using ICO Floor Coating SY at about 15 mils, applied in a single coat 5. Expansion joints were then routed out, filled with backer rod and topped off with our flexible joint material, ICO Lastic – an epoxy/urethane resin with a 140% elongation.

The ICO Floor Coating was selected for a number of reasons. It is a self-priming material that is a low enough viscosity to level to a very smooth surface. Applied at a minimum of 10 mils by squeegee and then back rolling it does fill in some of the gouges and divots in the floor, leaving a relatively smooth surface. As it is a flexibilized epoxy coating, it is not as likely to chip or crack under impact as compared to more conventional epoxy coatings. While our higher build self leveling epoxy, ICO Floor SL, installed between 1/16-1/8" in thickness, would have done a better job of filling in some of the defects in the concrete, because of budgetary constraints, the Air Guard opted for the thinner coating system. The Ure Guard 60 material was chosen as a top coat because of the need for maintaining a high gloss and providing UV protection.

The combination of the epoxy coating bottom coat and top coats of urethane has proven to be an excellent, economical answer to the Guard's flooring problem. Of course, the contractor skill in being able to grind the floor flat was also instrumental in the successful outcome to the project. The Air Guard is particularly happy with the new safety striping that has proven extremely durable in resisting wear and abrasion. At least three more such South Dakota facilities are planned to be redone as time and monies permit.
