### Case Study: Sugar Refinery

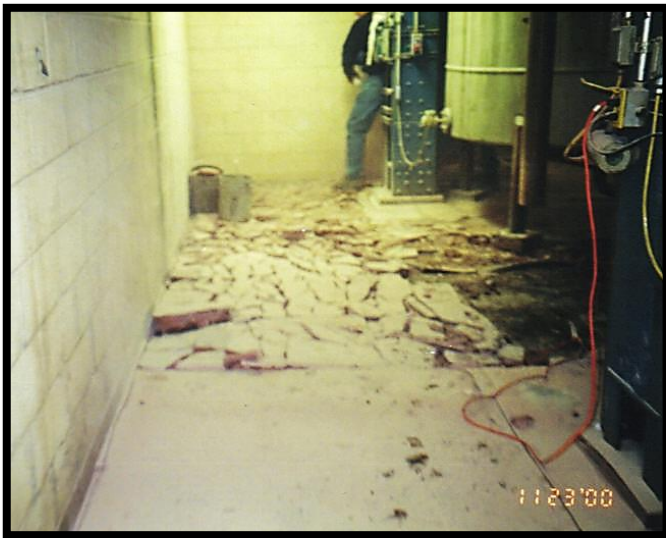
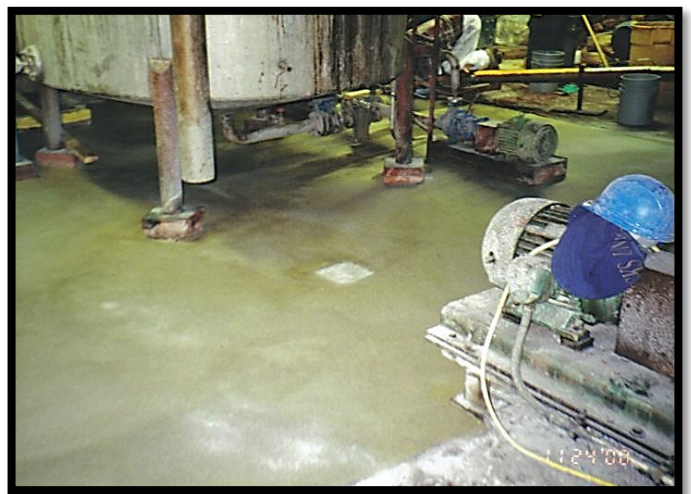
A New York sugar refiner was experiencing extreme concrete attack in a 5<sup>th</sup> floor wet processing area in their liquid molasses line. The concrete was severely eroded and cracked which allowed water to migrate down to lower levels. The company had a very short window of opportunity to correct this problem. Concrete was removed with jackhammers down to sound substrate. Much of the concrete was 4" (101 mm) thick. **3700 Grout** was then poured back in place and allowed to cure. **3700 Grout** was then sealed with **1000 CS**. The 2,000 ft.<sup>2</sup> (200 m<sup>2</sup>) project was completed in 36 hours.

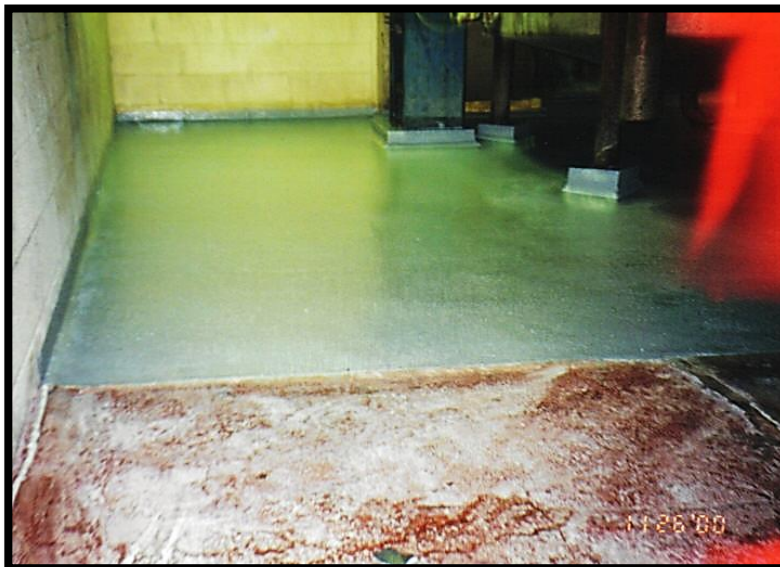
The installation has eliminated the chemical attack and stopped the water migrating to the lower levels for the past 5 years.
