Case Study: Florida Juice Company

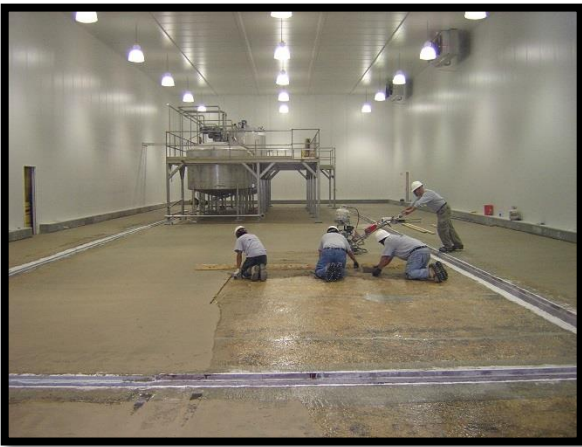
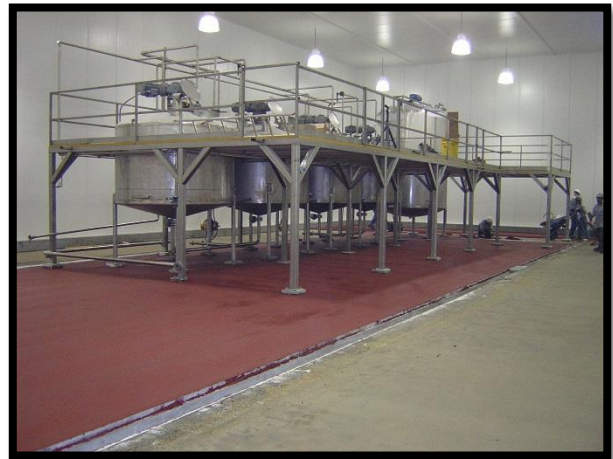
A Florida juice company required additional processing capacity without constructing an addition onto the plant. It was determined that an 8,000 sq.² (800 m²) warehouse area could be transformed into production space. The company installed new trenches to accommodate the juice process plus daily wash downs. The room was then pitched to the trenches with **3500 Grout** to eliminate the possibility of standing water. The thickness of the **3500 Grout** ranged from 3" down to ¼" (76mm to 6mm). **3300 FS** was then installed over the grout at a thickness of ¼" (6mm). The **3300 FS** was then sealed with **1000 CS** at 15 mils (380 microns). Silica was backrolled into the **1000 CS** to provide a non-slip surface. The project was completed in five days.

The room was put into production 2 weeks sooner than projected due to the quick cure times of the materials and efficiency of the crew. There have been no problems with standing water or chemical attack from the acetic acid in the juice or the cleaning solutions. The room experiences heavy forklift traffic with no sign of wear after two years of service.
