Case Study: Recovery Boiler

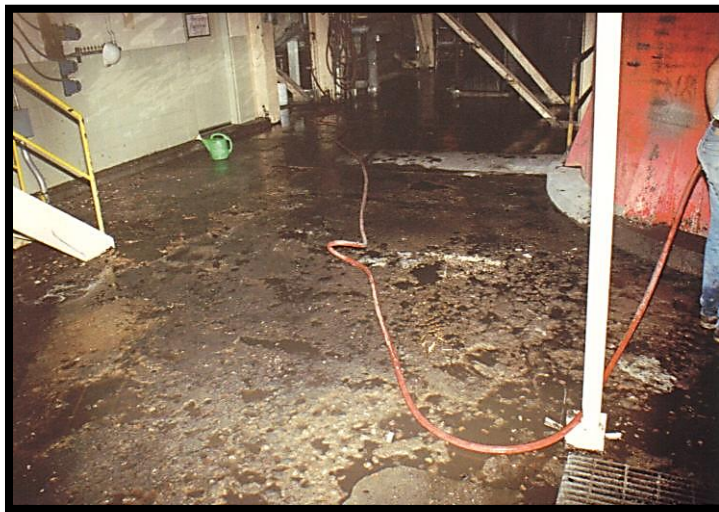
Before

The floor around the recovery boiler in a pulp & paper mill was badly deteriorated from acid and other harsh chemical spills. It became so rough that it became a safety hazard; large puddles stood everywhere, and cleanup was virtually impossible. Preparation was done to the existing floor, and pitch toward drains with 5500 Grout. The grout was overlaid with chemical resistant 6000 Flooring. The floor has a seamless non slip finish that is impervious to the harsh chemicals present. The puddles no longer exist, and spills run toward the drains.
