Case Study: Cornell University

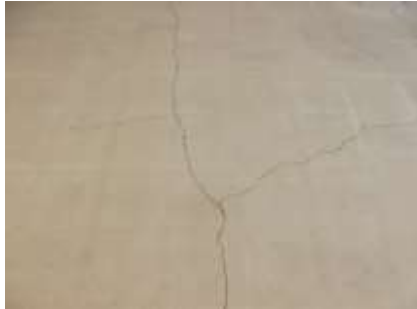
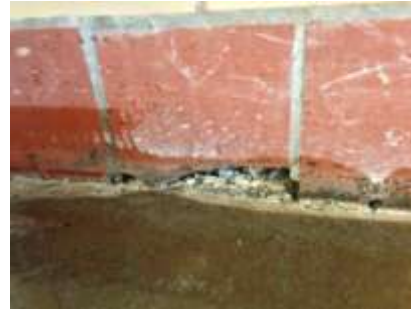
Cornell University renovated their gross anatomy classroom floors before the beginning of the 2015 school year. Kevin Bishop from KB Coatings & Contracting, along with Eric Fisher of Milamar, noticed that the new concrete slab had cracked throughout which was going to result in a huge problem for the floor as corrosive conditions were expected. The 2,200 sq. ft. room required a comprehensive coating system to protect it from the conditions it was going to be exposed to.

Prep work for the flooring included shotblasting and diamond grinding. Milamar's M1 MVE, ICO Lastic, Primer LV, Hi-Guard Slurry, and Hi-Guard Coating was the recipe for success for Cornell's flooring system.
