## Case History – BNE Iron Guard Installation - GoldCorp

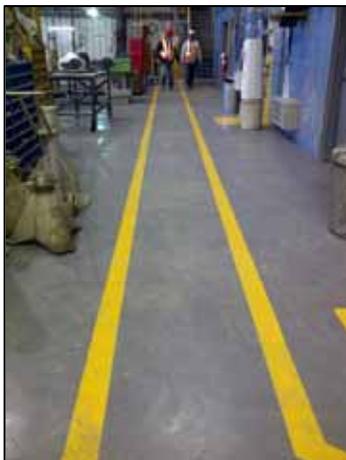
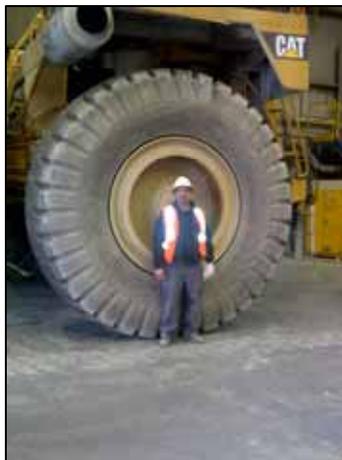
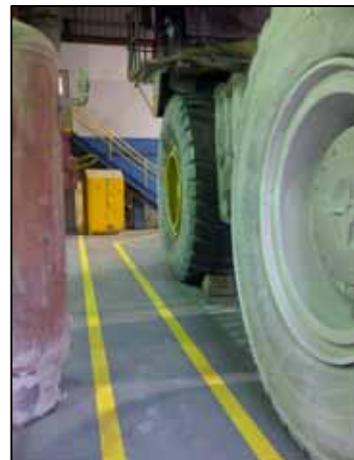
The floor in their Vehicle Maintenance Shop was heavily pitted because of the enormous amount of heavy wear and abuse it sees. In this area they maintain mining equipment and their fleet of trucks that can weigh more than 225,000 lbs. Their mechanics were having difficulty rolling their toolboxes over the uneven surface safely and using their roller carts to get under the vehicles and equipment. Several times the concrete was removed and replaced and a metallic shake hardener was tried without success. These options were very expensive and required extensive downtime for the concrete & toppings to cure enough for heavy use.

The 12,000 sq/ft area was divided into two 6,000 sq/ft sections so GoldCorp could continue their maintenance operations during installation. BNE ground the rough areas to remove loose, old concrete and toppings. Then they shotblast the area to remove oil and containments and provide a good profile for the epoxy to bond. All drains and entrances to the shop were keyed approximately a 1/2". After the floor was prepped the area was primed with deep penetrating ICO Primer LV at 200 sq/ft per gallon and silica sand was broadcast into the primer to provide a good bite while power troweling. The Primer LV was allowed to cure overnight and the Iron Guard was power troweled in 6-7 hours for a single lift at a 1/2" nominal thickness. Each section took three days to prep, prime, power trowel, and install safety lines. They client was able to return the floor to service 24 hours after installation.
