Case Study: S.C. Johnson & Sons

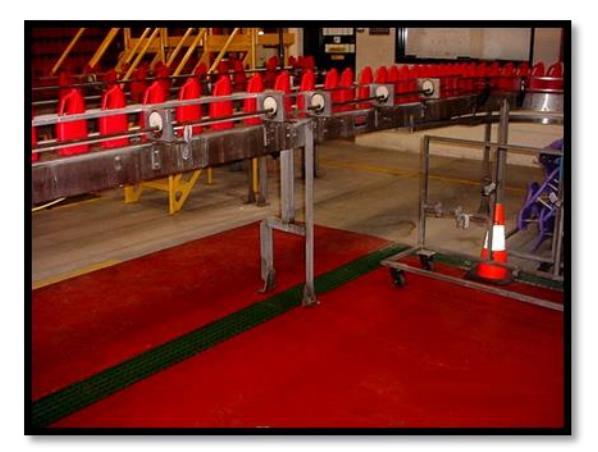
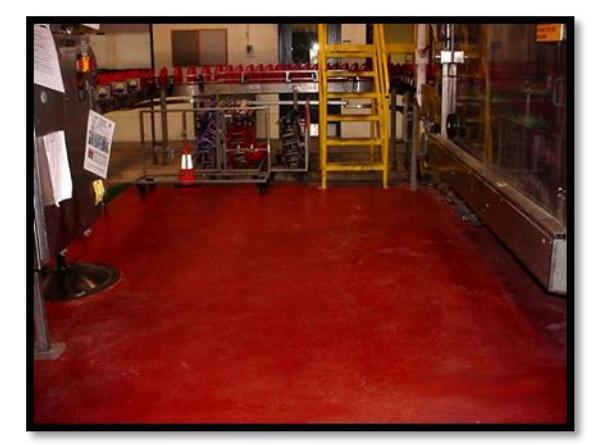
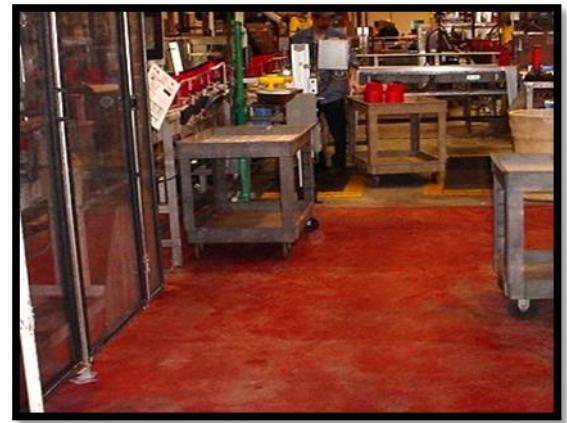
S.C. Johnson & Sons in Racine, WI was having problems with their floors around their Drano products filling lines. Occasional spillage of the Drano was deteriorating their previously installed floor coating and making the floor very slippery, creating unsafe working conditions. Their Engineering Product Manager was looking for a floor coating that could stand up to the corrosive properties of Drano while being safe for his employees to walk on while wet and easily cleanable.

The contractor, Creative Maintenance Solutions, first removed the old floor coating and any loose concrete was completely removed and patched with ICO Guard 51. The three-part, odorless, ICO Guard 51 was trowel applied at about 27 SF/gallon, anti-slip characteristics were enhanced by broadcasting in silica quartz. For ease of cleanup and an enhanced appearance a topcoat of ICO Guard Coating in Tile Red was applied at about 10 mils thick. The customer is very pleased with the results and the floor is holding up well to the Drano. Most importantly the floor provides a much safer working conditions for his employees. After almost a year of use, the floor has held up well and has provided the safety and appearance desired by the customer.
