TRANSFORMS

In 2007 there was a \$70 million renovation project to both restore its art deco reputation and add a modern edge and style. Unfortunately, in 2010 the hotel suffered from a major flood from equipment failure in a 7,000-square-foot mechanical area on the hotel's fourth floor causing significant damage to the floors below.

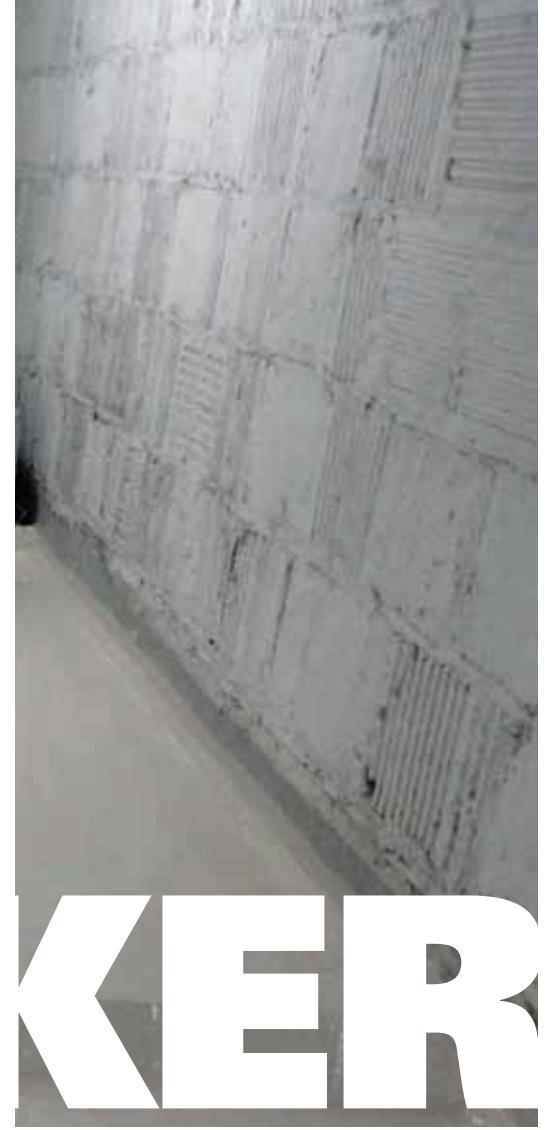
Before and After photos of the clean-up at the New Yorker Hotel in 2010. All photos courtesy of International Coatings, Inc.

The concrete floor was scarified to provide a clean sound surface for the epoxy to bond. Six new drains were installed in the mechanical room to properly drain areas. Concrete curbs (4' x 4') were fabricated to act as a containment area. At all entrances six inch high concrete ramps were fabricated to ensure that water would be contained and not spill out into the hall and other floors. Without a lot of movement, all the cracks and joints in the walls and floors were filled with ICO Gel. Expansion joints were filled with ICO Lastic Gun Grade. Next the whole area was primed with ICO Primer LV, a low viscosity primer that deeply penetrates the substrate and provides an excellent mechanical bond. Lastly the ICO Lastic was applied with a squeegee at 60 mils thick and then and then spike rolled with a porcupine roller to help release air.

There was a trouble spot in an area that at one time held a piece of machinery that leaked oil. The oil kept on resurfacing despite scarifying the concrete and repeated cleanings. Sutherlann decided to try and use ICO Gel as a skim coat prior to the ICO Primer LV and ICO Lastic. Sutherlann's creative thinking paid off and the ICO Gel's tenacious bond and heavier application prevented the oil from reappearing.
