PET FOOD FLOOR:

Dogged By Problems

One of the world's largest pet food manufacturers needed to upgrade the flooring in their Colorado facility because it was not pitched to properly drain.

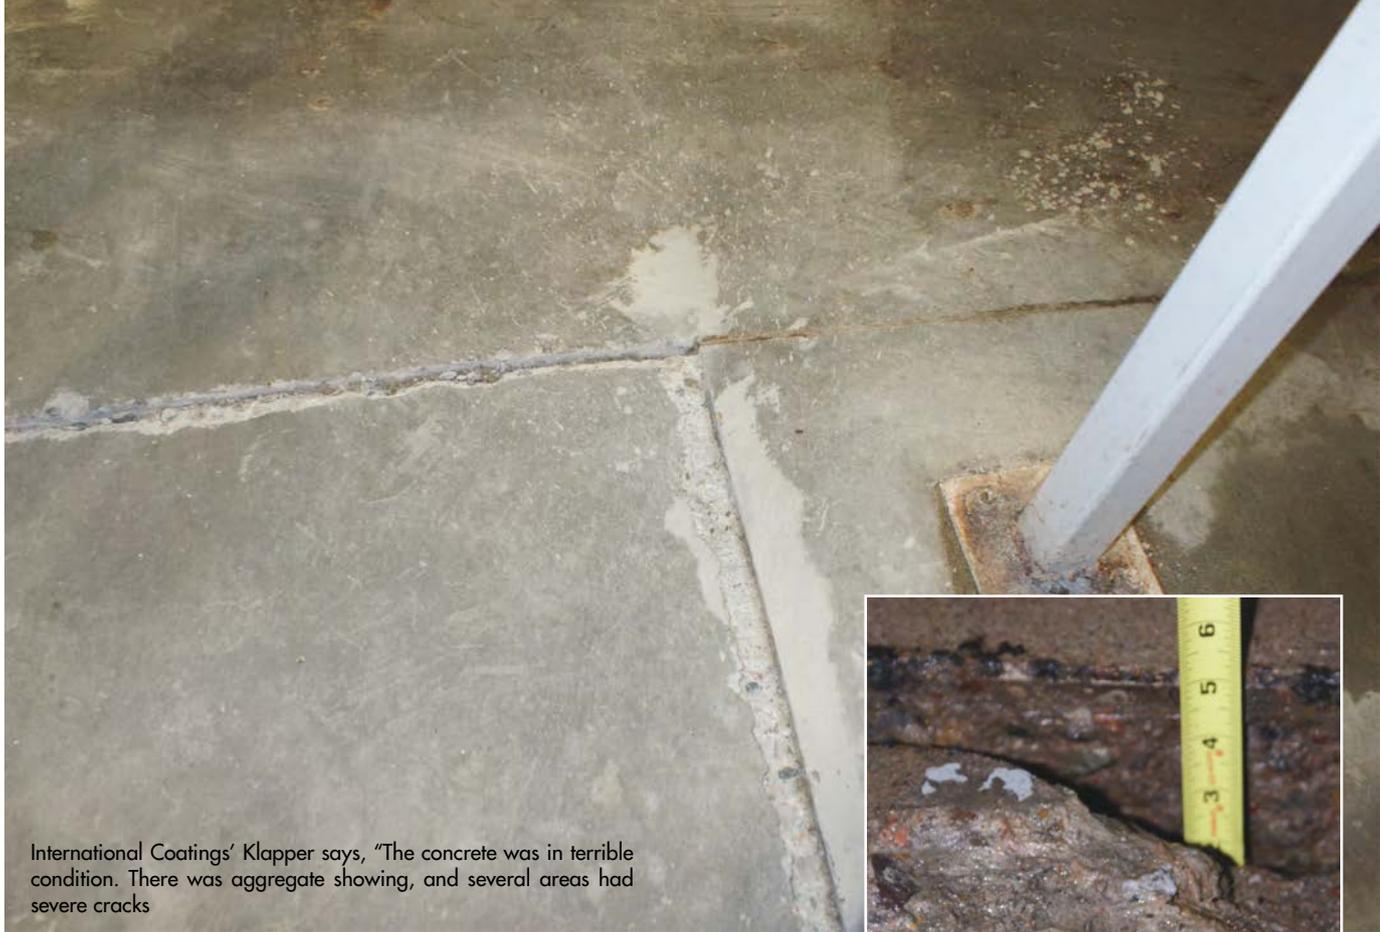
International Coatings' Klapper says, "The concrete was in terrible condition. There was aggregate showing, and several areas had severe cracks

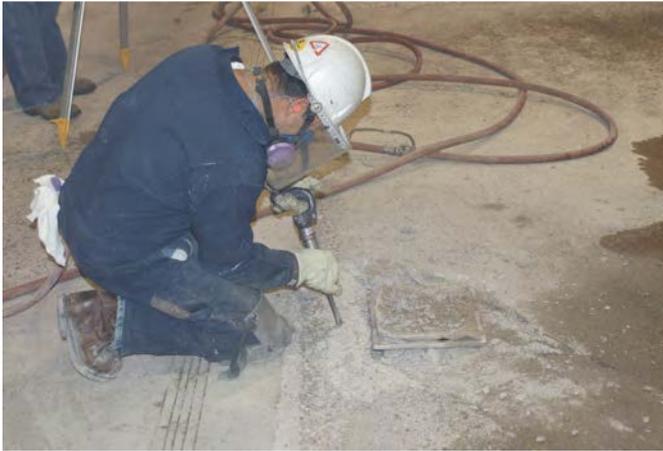
ABOVE ▲ The Behunin crew used Ingersoll Rand air saws, pneumatic chipping hammers, and scaling hammers to remove delaminated coating and unsound concrete.

With men and machinery protected, the crew used Ingersoll Rand air saws, pneumatic chipping hammers, and scaling hammers to remove the delaminated coating and any unsound concrete. “We used a wet diamond grinding process to cut the concrete, which limited the dust. Then a plumber came in to install the new drain,” Behunin says.

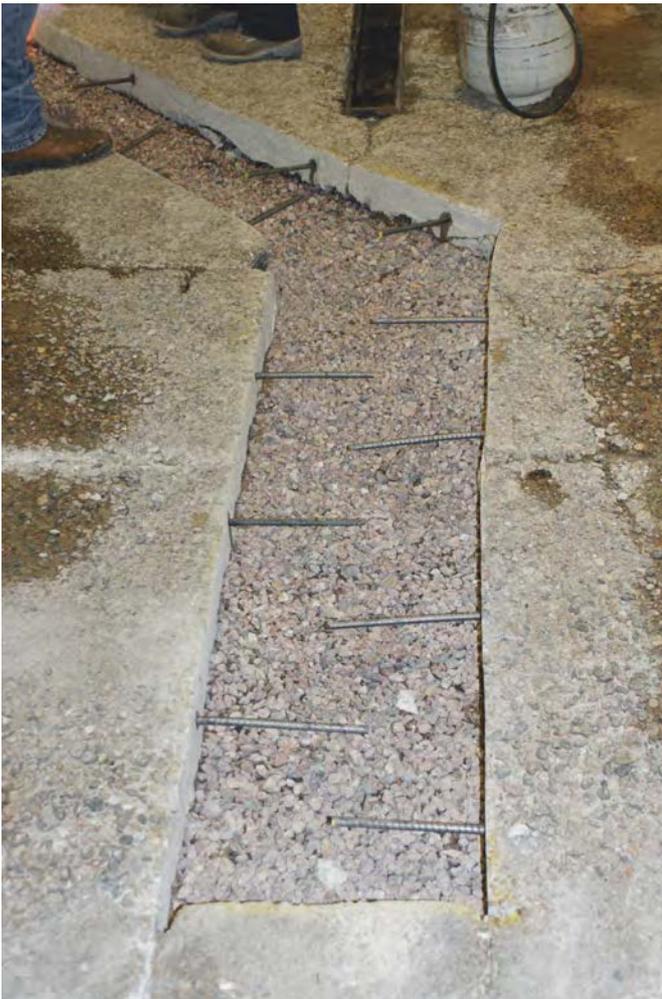
BELOW ▼ “There are no control joints in this monolithic floor,” Behunin explains, “so we drilled ½” (1.27cm) rebar dowel into the concrete for reinforcement.”

concrete for reinforcement.”

When the plumber was finished, Behunin and his crew refilled any unsound spots on the old floor using back fill and tamping it into place. “There are no control joints in this monolithic floor,” Behunin explains, “so we drilled ½” (1.27cm) rebar dowel into the

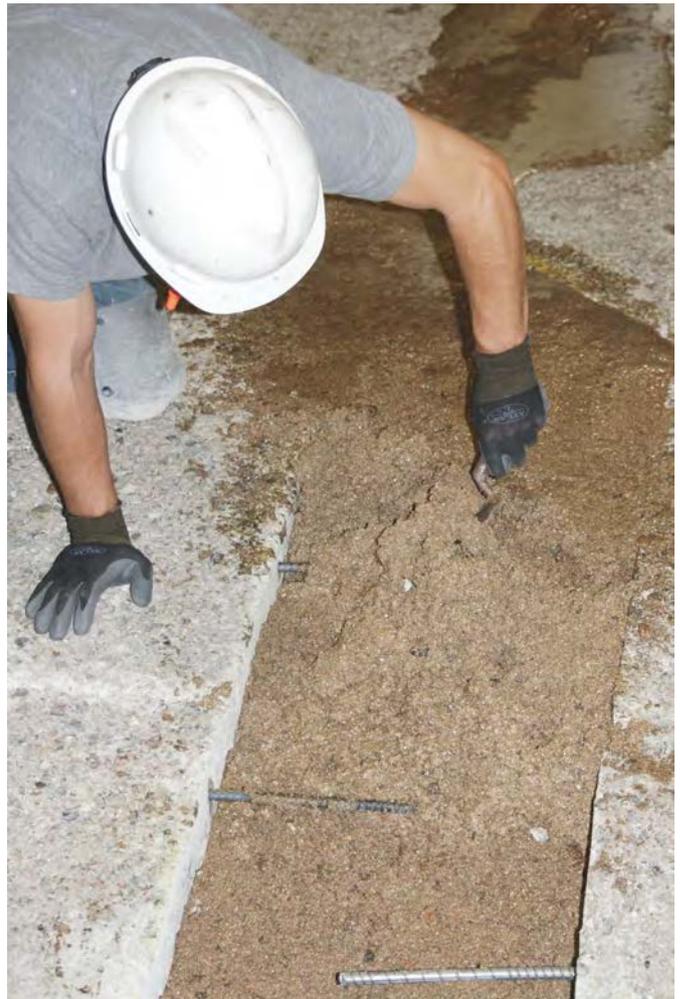
BELOW ▼ After a plumber had installed a new drain, Behunin and his crew refilled the trench using back fill and tamping it into place.

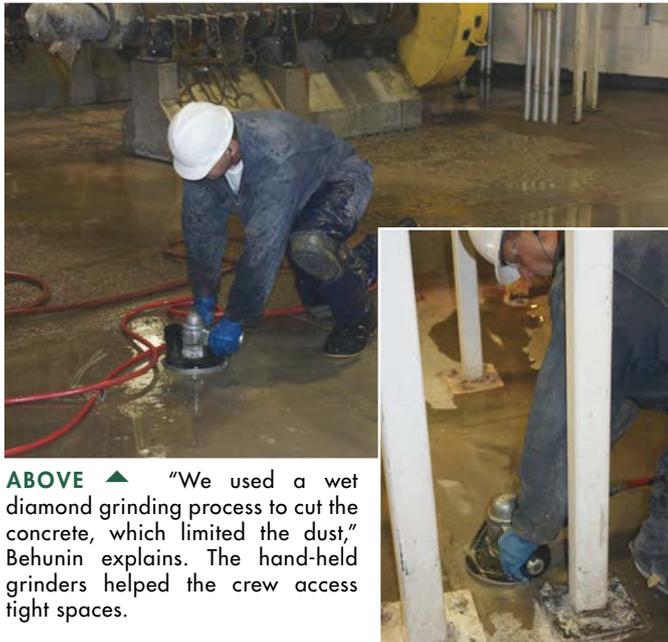
ABOVE ▲ "We used a wet diamond grinding process to cut the concrete, which limited the dust," Behunin explains. The hand-held grinders helped the crew access tight spaces.

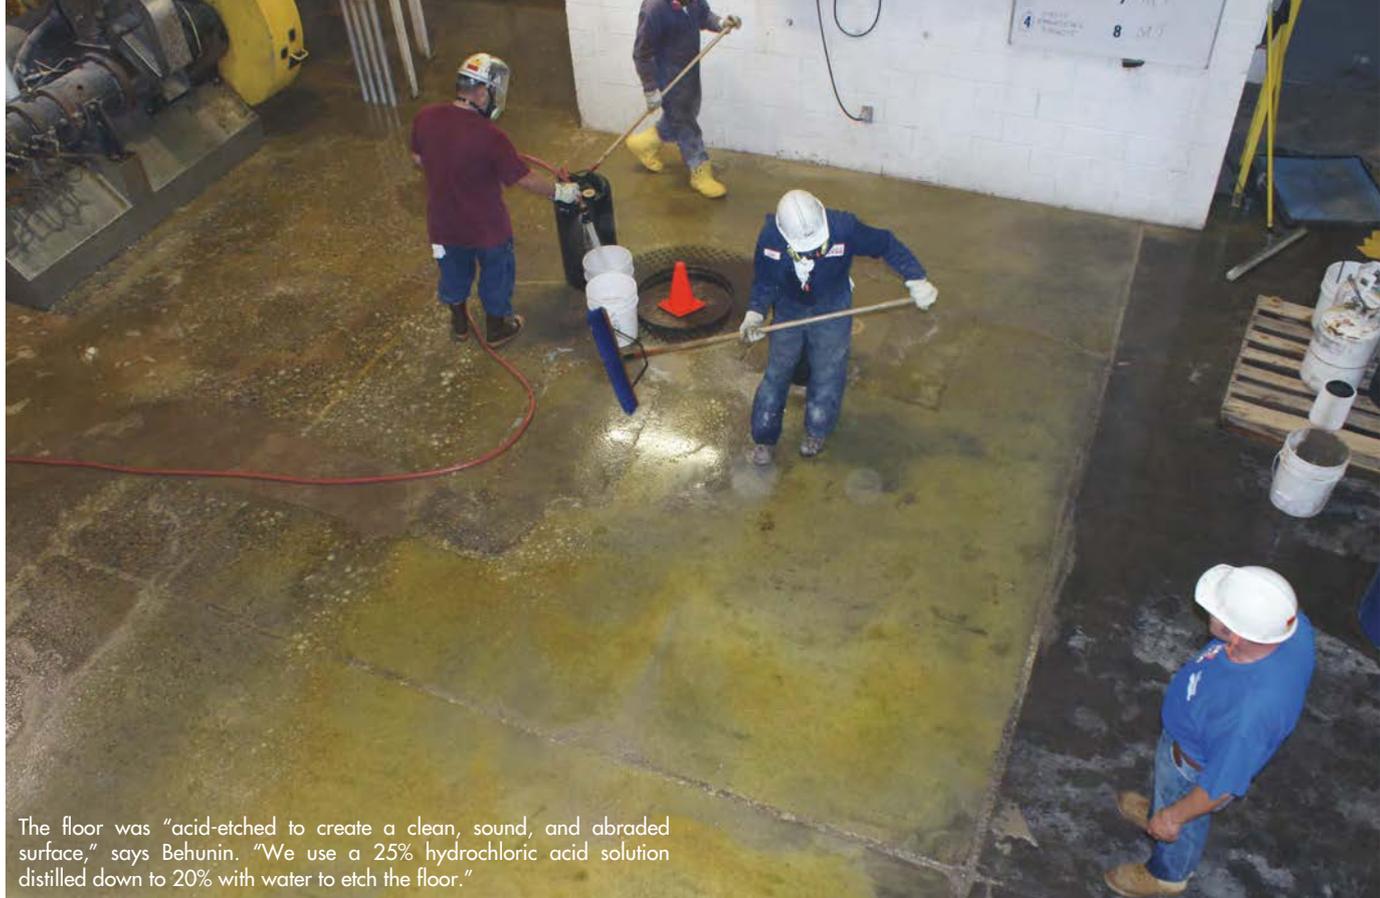
The floor was "acid-etched to create a clean, sound, and abraded surface," says Behunin. "We use a 25% hydrochloric acid solution distilled down to 20% with water to etch the floor."

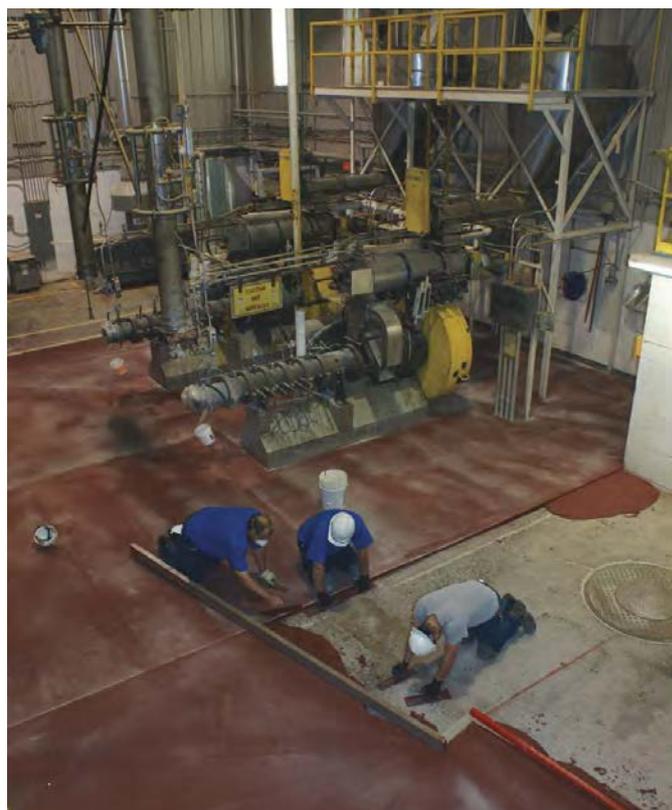
ABOVE ▲ "To create the slope," Behunin says, "we had to build the floor up to a thickness of 3" (7.62cm) in some places, tapering down to ¼" (0.64cm) at the drain."

"To create the slope," Behunin says, "we had to build the floor up to a thickness of 3" (7.62cm) in some places, tapering down to ¼" (0.64cm) at the drain. The ICO-Guard 51 is self-priming, so once the concrete was clean and prepped, we could start coating. We didn't have to wait for a prime coat to cure."

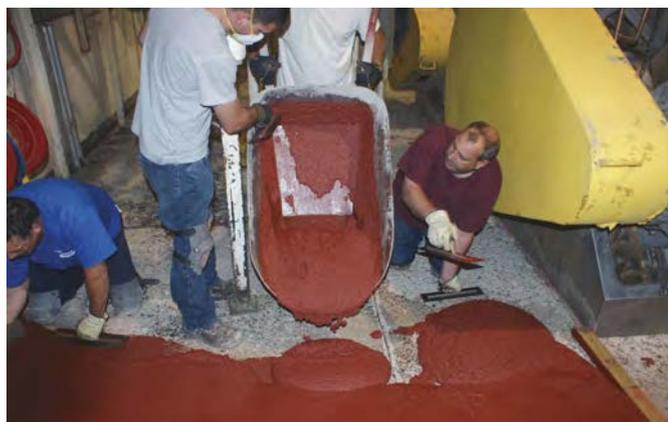
LEFT ◀ The crew used a screed box and trowels to apply ICO-Guard 51 onto the floor, hand-broadcasting 20-grit sand to excess into the wet material to create a non-skid surface.

In a further time-saving step, "we hand-broadcast 20-grit sand to excess into the wet material to create a non-skid surface," Behunin says. "Because we broadcast the aggregate directly into the coating, no topcoats were necessary."
