PROGRESSIVE DAIRYMAN

Repairing milking parlor flooring: What are the options?

Written by Mike Kramer

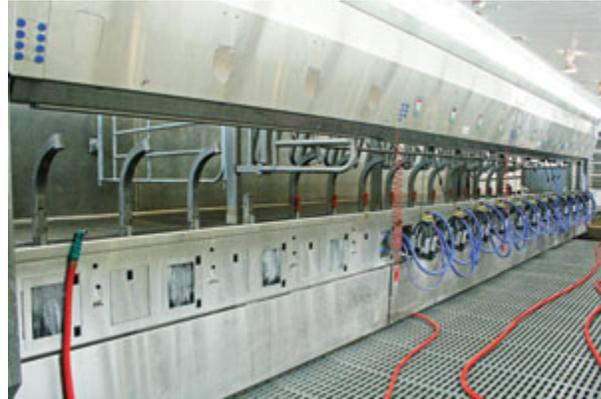
Lactic acid will attack unprotected concrete, as will chemical cleaners. Over time the surface “cream” will be eaten away, leaving larger stone exposed, which will only accelerate the deterioration. Hastening this process is the constant impact of cows’ hooves which gradually breaks down even higher-strength concrete, and constant thermal shock from hot water sanitary washdowns can result in spalling of the concrete, particularly if cracks have formed from ground settlement. This inevitable deterioration not only presents a safety hazard for the cows as holes deepen but presents a serious challenge to effective sanitation, as the concrete skin is eroded by chemicals and impact. Once exposed aggregate appears, it is time for repairs.

A most effective repair involves installation of a chemical-resistant, heavy-duty polymer topping, usually applied a minimum of one quarter-inch or considerably thicker if concrete erosion is significant. Flexibilized epoxies or urethane cements are the most commonly accepted materials to use, as they present the best combination of longevity, ease of application and cost. Acid brick is another alternative, as it will provide many years of use with minimal repairs; however, its lengthy installation process and high cost must also be considered. Once the decision has been made to make the repair, the selection of the exact material to use becomes of paramount importance. There are of course many available materials but certain criteria should be followed to ensure a satisfactory flooring repair:
