Case Study: Concrete Protection for Detention Centers

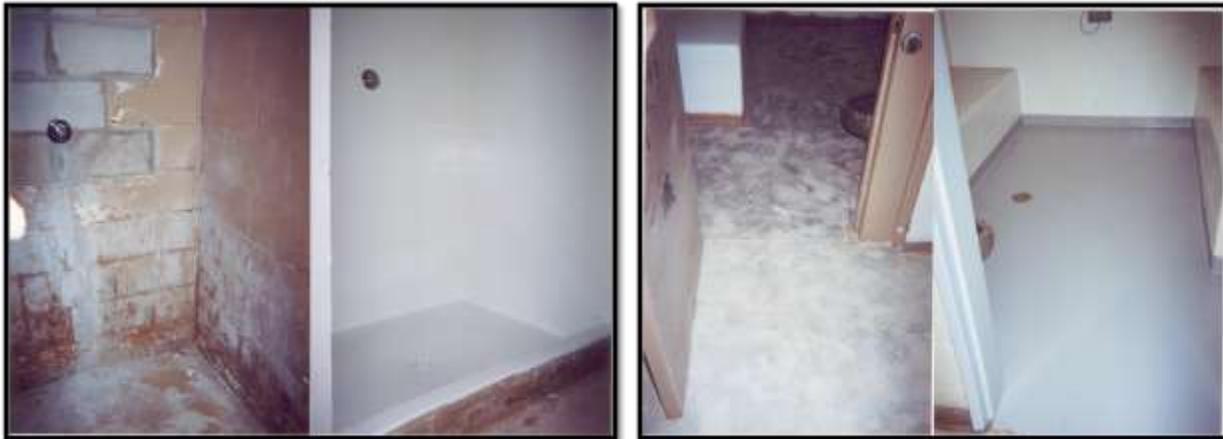
There are some specific areas that historically offer the greatest and most frequent problems because the conditions include daily use, under wet conditions, with a need for sanitary conditions. Good examples are shower areas, kitchens, and cafeterias. We have never encountered any personnel that did not complain of the problems of maintaining these areas prior to the use of Milamar's ICO Floor Coating on the floors and ICO Glaze on the walls of shower stalls. The first picture reveals shower stalls at the Hampton County Detention Center in Hampton South Carolina. The paint was constantly peeling and required recoating every 6 months. In paint off the surface down to a solid, clean substrate. In this application the ICO Glaze system, including ICO Gel to smooth the joints was applied on the walls. The contrasting photo is ICO Glaze after 4 months of use. The striking difference is testimony to the tough, mold, graffiti and damage resistant characteristics of ICO Glaze.

The floors have added difficulty as they are subjected to harsh cleaning, constant traffic and must be skid resistant. The best performing material found by institutions for this area is the ICO Floor Coating also seen in the finished photo. The system includes ICO Primer LV, and two coats of the Floor Coating. The first coat receives a broadcast of aggregate to provide the required skid resistance needed in shower areas.

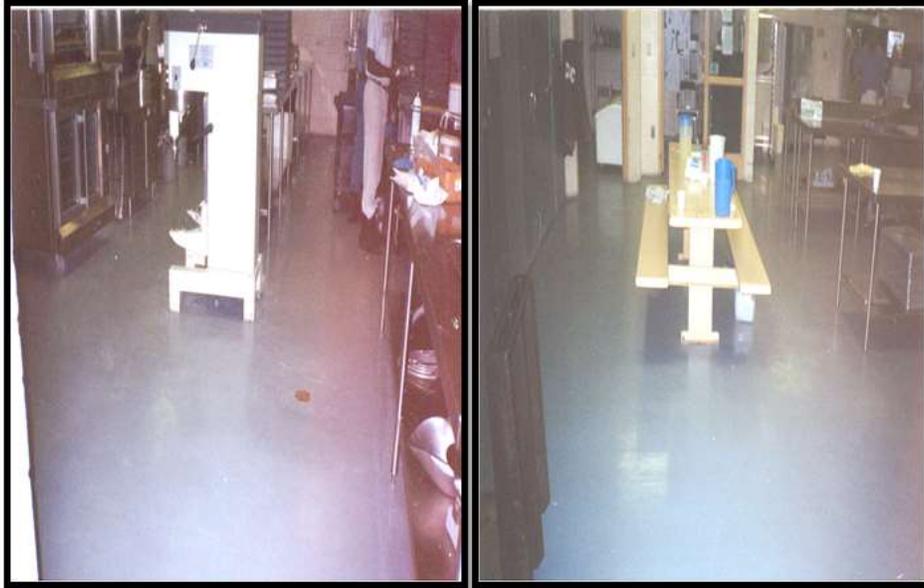
The same coating ICO Floor Coating is an excellent covering for hallways, cafeterias, and cell floor. The second of pictures shows the use of ICO Floor Coating in the Georgetown Detention Center in Georgetown South Carolina. Also shown are hallways that were sealed with only ICO Primer LV to minimize costs while maximizing performance and facilitating the ease of cleaning and maintaining the floors.
