Case Study: Gateway FS, Inc.

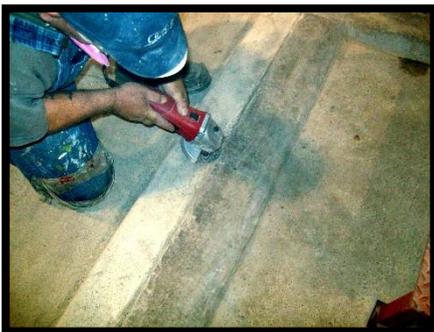
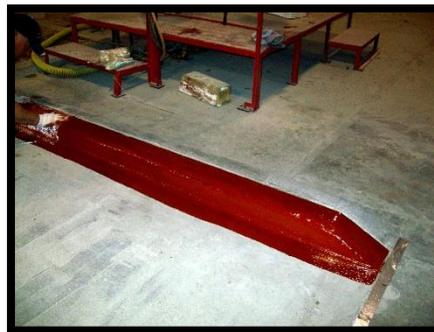
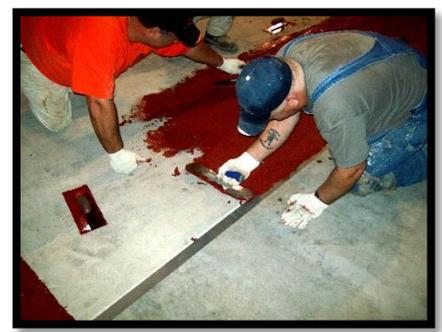
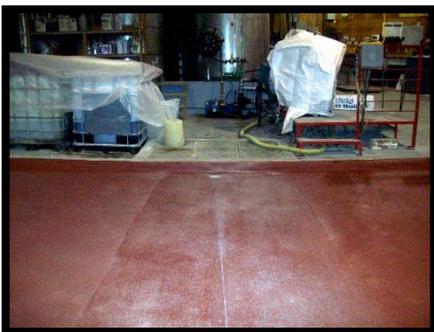
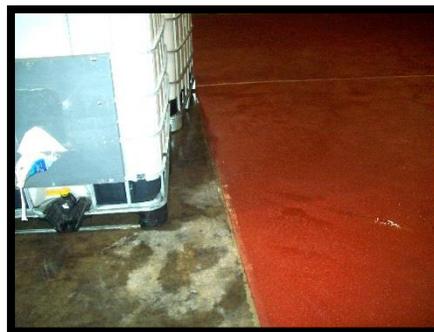
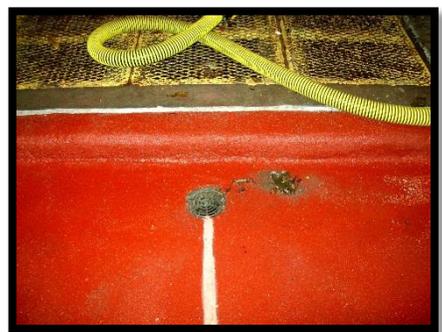
Gateway FS, Inc. is a locally owned agricultural cooperative serving producers in Monroe and Randolph counties in Illinois. Formed in 1931, Gateway FS, Inc. is a leader in meeting producer needs in production agriculture and crop marketing. They were having problems with concrete deterioration in their chemical mixing and fill areas. They'd tried several different flooring solutions but they all failed due to heavy traffic and chemical attack. They looked to Milamar Coatings rep, Dan Deckert of TCR Coatings, for a solution.

The first step was to remove all of the old coatings and prep the concrete by shotblasting and grinding. There was a curb that was to be coated as well and because of the amount on movement Dan recommended embedding fiberglass scrim cloth into the system. Keyways were cut at all the termination points to provide a solid anchor. The ICO Hi – Guard was then trowel applied at ¼" thickness.

Dan knew that it would take a substantive system for the heavy loads that drive over this area and since this it sees many different chemicals in many different combinations a highly chemical resistant coating application was required. Dan recommended ICO Hi Guard applied at a ¼" thickness. ICO Hi Guard is a novolac epoxy with excellent chemical resistance to many concentrated acids, most alkalis and some solvents. The enhanced toughness of the system allows for better resistance to thermal and mechanical shock compared to more conventional materials.

After over a year of service, the film is holding up exceptionally well, with no sign of wear and tear. For non-traffic areas, such as secondary containment, a thin film version of the ICO Hi Guard is available. The customer has been extremely pleased with the toughness and durability of the system and it has exceeded their expectations.
