Case Study: Papé Machinery

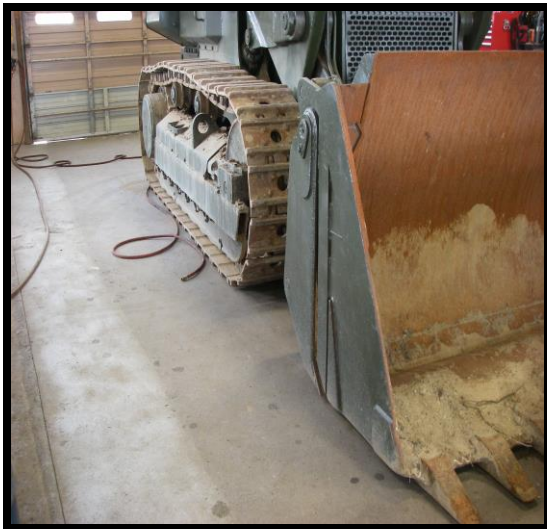
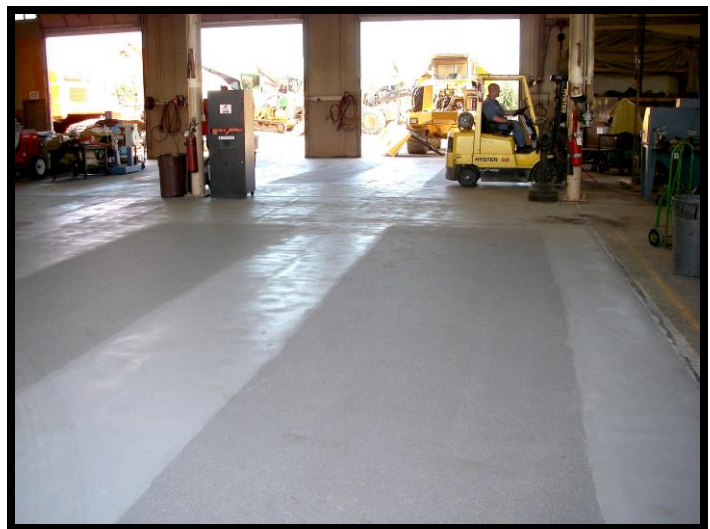
Dunkin & Busch the ¼" topping in three separate four day periods so some of the bays could remain operational while they were doing the installation. They first thoroughly washed the concrete with a citrus-based cleaner to remove any oil and fluids from the concrete. They then blast-tracked the concrete to obtain a clean, sound, abraded surface for the epoxy to bond with. They also routed out any cracks and pre-filled some of the deeper holes and more severely spalled area.
