## Case Study: Sparhawk Animal Pharmaceutical Lab

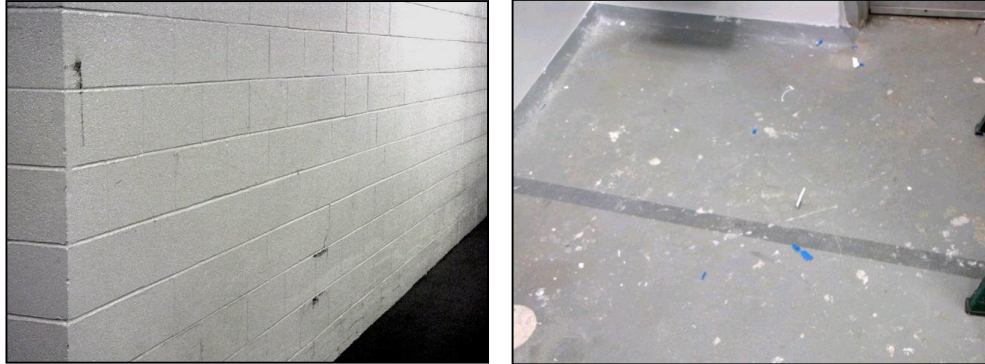
Sparhawk Labs is a leading manufacturer of animal pharmaceuticals. Facility Plant Engineer James Capell had an area in their manufacturing facility that the company required upgrading. The painted cinder block wall was difficult to clean and the floor and ceiling required new coating as well. A completely smooth wall that was easily cleanable and could withstand the harsh chemicals used in their disinfection program was required. There was also a very short window for the work to be done while several other building trades worked at the same time. The coating contractor would have to be able to mitigate dust and odor during the installation.

After diamond grinding the existing wall paint Uni Floor used ICO-Gel Fast Cure in white to fill and smooth out all the old mortar joints and bug holes. They used a state of the art dust free diamond grinder with a 60 grit tool to remove any protuberances and another coat of ICO Gel Fast Cure white was applied and again diamond ground. For particularly uneven areas, a third application of the ICO-Gel was applied. After diamond grinding the ICO Gel to a completely smooth surface, two coats of ICO Glaze Top Coat in White were applied at about ten mils thick each. To obtain a high gloss finish, a final coat of ICO Ure Guard 100 white was applied at about 5 mils. The same system was applied to the ceiling and ICO Floor Coating in gray 101 was installed on the floor. The glossy surfaces made a once small dark room very bright.
