## Case Study: Stone Mountain Pet Lodge

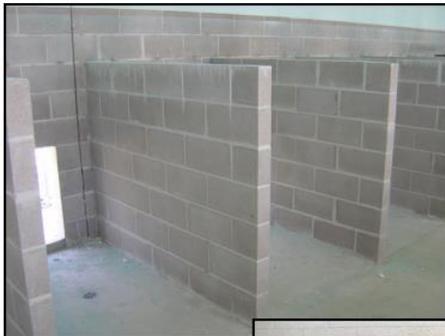
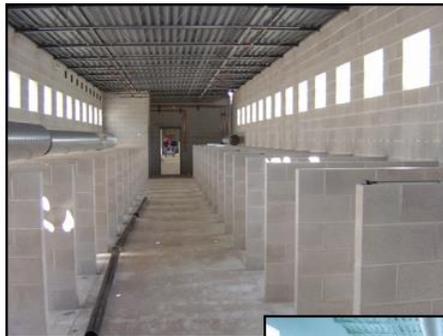
Before

QCRC had done work for several kennels before and knew that ICO Quartz 120 DB on floors combined with ICO Quartz Cove and ICO Glaze on the walls would provide the quality system the Stone Mountain Pet Lodge required. After prepping the concrete by shot blasting and diamond grinding QCRC installed ICO Quartz 120 DB. It's a 1/8" thick, seamless, double broadcast system that's odorless and non-toxic. Next they installed a cove using the ICO Quartz Cove product. It has the same great look, durability and chemical resistance as the ICO Quartz 120 DB and provides a seamless transition from floor to wall that leaves no place for debris to collect or bacteria to hide. Lastly, the new block walls QCRC installed ICO Glaze, a completely seamless epoxy coating system applied in three steps that dries to a high gloss, ceramic-like finish. It's impervious to moisture and has excellent chemical, impact and thermal shock resistance.
