Case Study: University of Colorado

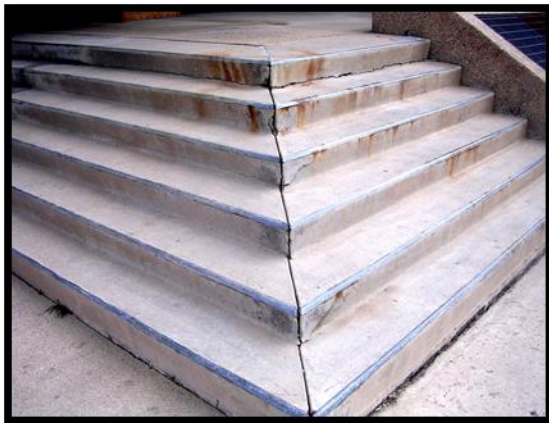
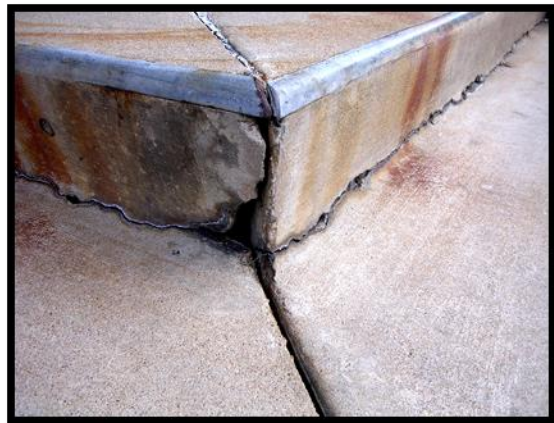
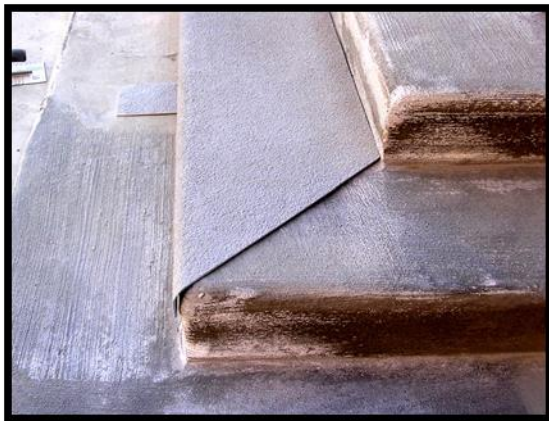
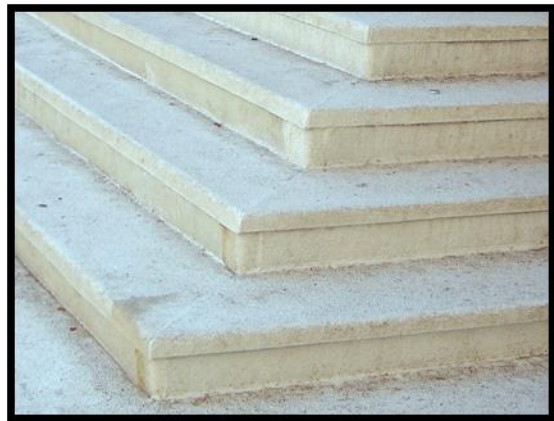
The University of Colorado in Boulder, CO had been experiencing problems with the deterioration of some of their concrete steps. The stairs had been compromised by cracks allowing water to penetrate and freeze-thaw to occur. Frost heaving is common in Colorado with daily temperature swings of 20 to 60 degrees Fahrenheit not unusual in the early winter and spring seasons. Constant use had also caused wear zones and uneven surfaces that were beginning to become a hazard.

Contractor Accentuate Construction was chosen to do the repairs. The first step was to remove all the old failing concrete, the stairs were then cleaned and acid etched to provide a clean sound substrate for the ICO Gel to bond to. The ICO Gel was then used to fill cracks and major holes and level the stairs that have settled or have been worn uneven. Once this has set up another thin layer of gel is applied to the stair and the fiberglass tread is embedded into the gel. This set of steps have already been in service at the University of Colorado for three years and Accentuate Construction is currently under contract to fix hundreds more over the next four years.
