## Case Study: Con Agra Foods

The Con Agra plant in Longmont, CO has been systematically upgrading their facility that not only serves as a turkey processing plant but also packages for direct retail consumption. Resurfacing of the concrete floors has been done by Tom Behunin Construction out of Arvada, CO, using Milamar Coatings' ICO Guard 51 epoxy flooring material, for over the past two years.

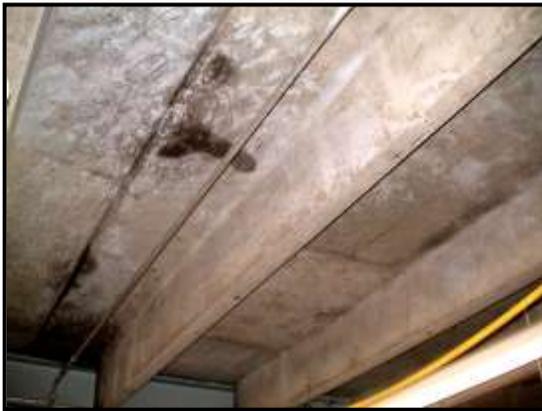
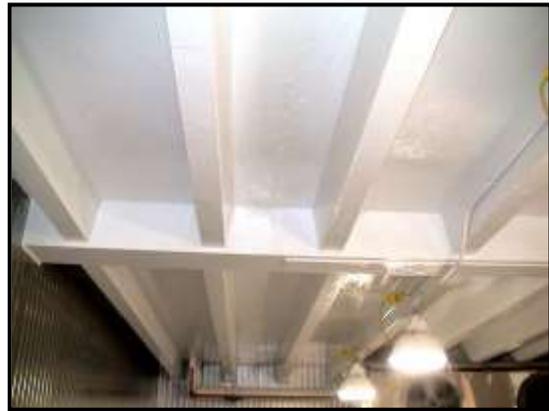
Ted Johnson, the plant engineer in charge of the modernization program, asked Tom to turn his attention to a 5000SF cooler room that not only had many layers of previously applied polymer floors that were constantly patched, as well as uncoated concrete T-panel ceilings that proved difficult to sanitize.

The ceilings were attacked first. After mechanically grinding the concrete to obtain a clean, abraded substrate, the applicator then applied Milamar Coating's epoxy filler, ICO Gel, to fill the many bugholes, followed by spray applying two coats of ICO Glaze Top Coat – a 100% solids epoxy coating with high build characteristics that can withstand high moisture and chemical cleaners. The final high gloss, seamless coating of 10-15 mils is now providing a complete vapor barrier designed to hold up to constant dampness and sanitizing chemicals.
