Case Study: Anheuser Busch

A new pasteurizer line was being installed at Anheuser Busch in Fairfield, California. Due to excellent past experience with ICO Guard 51 in the Van Nuys, California plant, Guard 51 was the preferred product for the floor of the new line by corporate engineering. ICO Guard 51 is the first product listed in the Anheuser Busch corporate flooring specification TP-70 and it has been used in their plants across the country including New York, Ohio, Missouri and Texas.

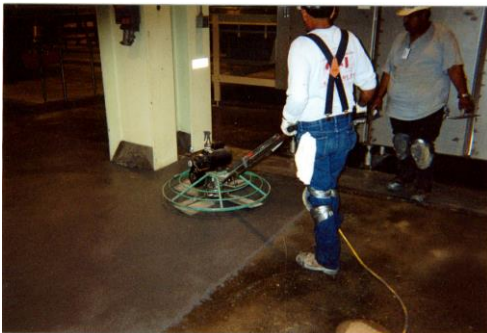
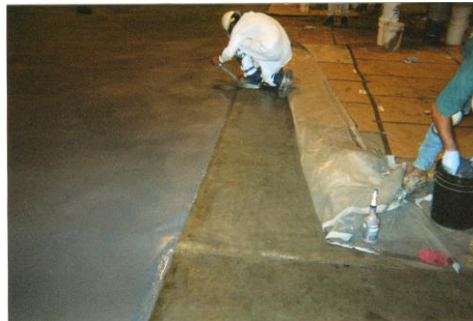
To provide a good profile the floor was shot blasted. All cracks and deteriorated areas were repaired. A key was cut around all drains and the entire periphery. The floor was primed with ICO Primer LV Fast Cure to minimize the curing period required before placement of the ICO Guard 51. At 60°F - 65°F the primer cured in 2 hours, (approximately the same time required to coat the 4,500 sq ft).

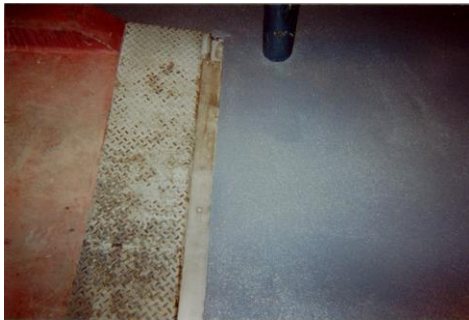
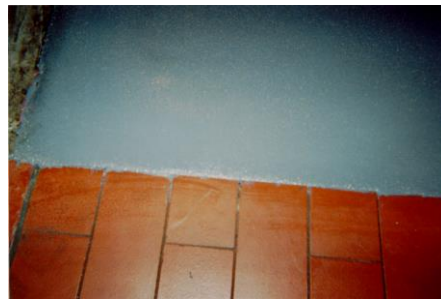
To maintain the rapid pace of application and curing ICO Guard 51 Fast Cure was applied by power trowel. The material was placed by screed box and finish trowelled by machine. No other steps were taken such as back rolling or seeding with sand. The entire 4,500 square feet required 5 hours to install. As a result the material placed first was cured as the last was just being laid down. In falling temperatures, low sixties down into the high fifties, the Guard 51 fast cure only required 4-5 hours cure for foot traffic.

The above- photo's show the application, neatness of the contractors finish, and the smooth surface texture. The two coat system, primer plus topping in the fast cure formula provided for a very rapid cure. The project was completed precisely on schedule.
