Case Study: Georgia Aviation Technical College

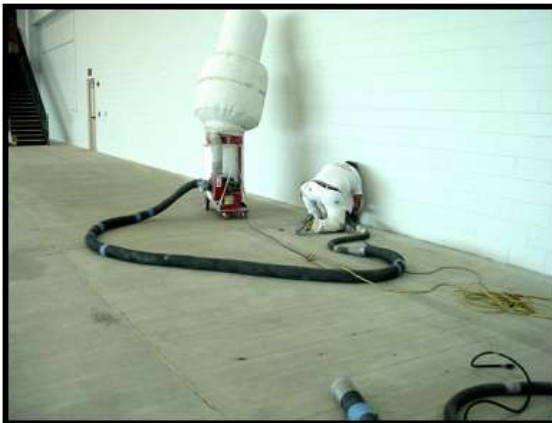
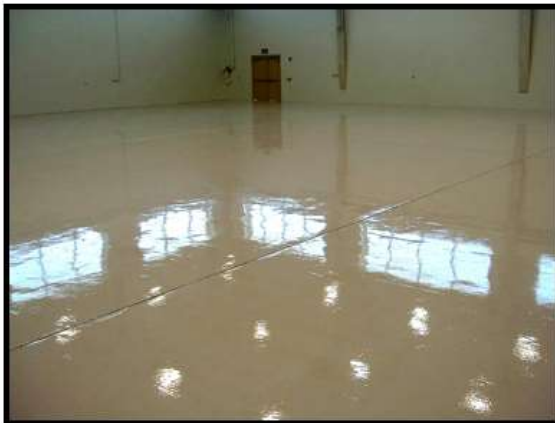
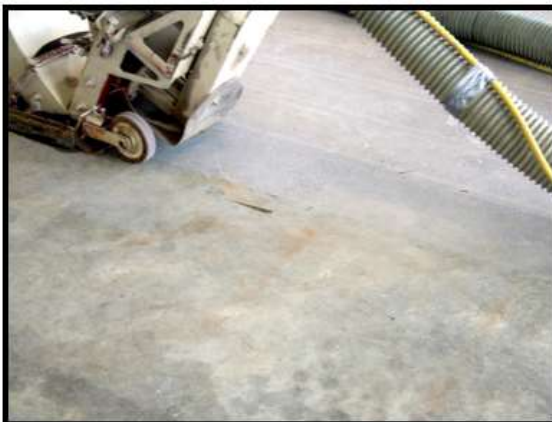
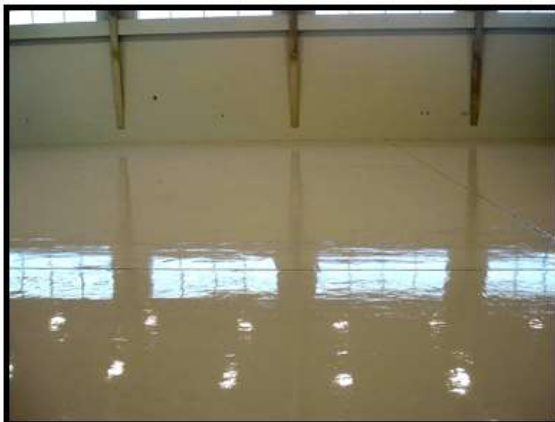
Over 28,000 sq/ft of concrete was cleaned and then blast tracked to provide a sound, abraded surface for the coating system. One coat of ICO Primer LV was applied at about 250 s/f per gallon. This highly penetrating primer provides an excellent mechanical bond and helps prevent outgassing. Then ICO Floor Coating was applied at about 160 s/f per gallon. ICO Floor Coating was used because of its high build characteristics, good chemical resistance (especially to Skydrol), and resilience. Finally a topcoat of ICO Ure Guard 60 was put down at about 350 s/f per gallon to provide UV stability, abrasion resistance and a high gloss, easy-to-clean finish. The final product is a high performing system that will provide years of virtually maintenance free service.
