Case Study: Coca Cola

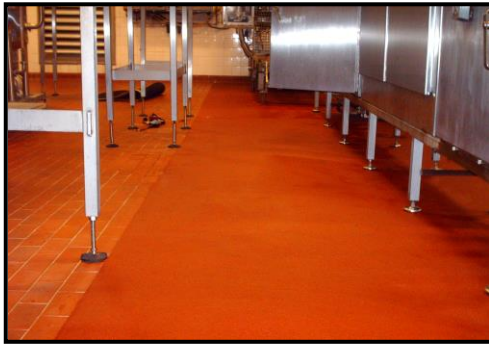
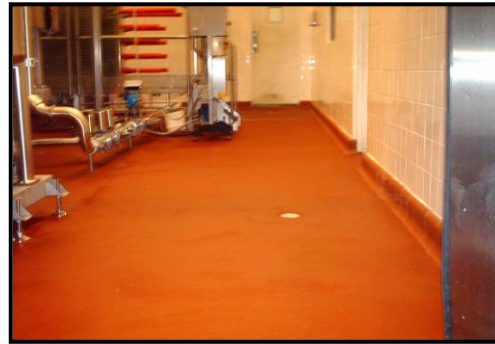
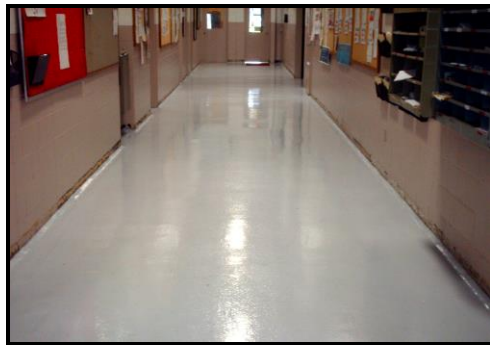
The filling room was 2,636 square feet of quarry tile that had several hollow spots. The grout had been failing in several areas and was in need of constant repairs. Daniel recommended Milamar's ICO Guard 51 at a $\frac{1}{8}$ " thickness because of the constant moisture, heavy wear, and wash-downs that are typical of bottling plants. In addition he only had from Saturday morning at 6am until Monday morning at 7am when they would need to be on the floor again, so the one step application of the Milamar ICO Guard 51 was crucial.

Daniel used a concrete chisel to remove the hollow tiles and deteriorating grout. He then used a 3 head diamond grinder to prep the sound tiles followed by a thorough washing with a cleaner/degreaser and finally a torch to dry the floor. The troweling of the material was very labor intensive because of the amount of equipment they had to go under. Another advantage of using the ICO Guard 51 was that he could fill in the areas where tiles were removed as he troweled the floor, he did not need to patch those areas first. While they were under one of the machines they discovered an oil leak that had to be fixed quickly before being able to proceed.
