Case Study: Jackson Beverage Company

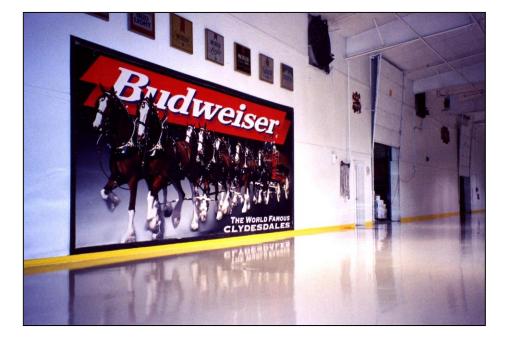
After drying, ICO Floor SL, ICO's flexibilized self-leveling floor, was applied to remove major surface defects and create a smooth floor (and provide better wear and impact resistance than a two part, thin film coating). A thin coat of ICO Ure Guard 60, a two-part aliphatic urethane pigmented with beige 104, was then applied for better UV resistance and color stability, followed by a clear coat of the same for minimizing ugly tire marks and facilitating cleanup. The client has been very pleased with the installation and with his new "showpiece" floor.

Steve Williams of Protective Coating Sales, Inc. in Henderson, NC recommended a four-step system that incorporated Milamar Coatings' epoxies and urethane coatings. After shot blasting the floor, Steve and his crew applied Milamar's ICO primer LVFC, a 100% solids, deep penetrating primer, that would help seal the floor and, with the additions of fine fillers, fill all the holes and other imperfections in the floor.
