## Case Study: Kuhlman Cellars

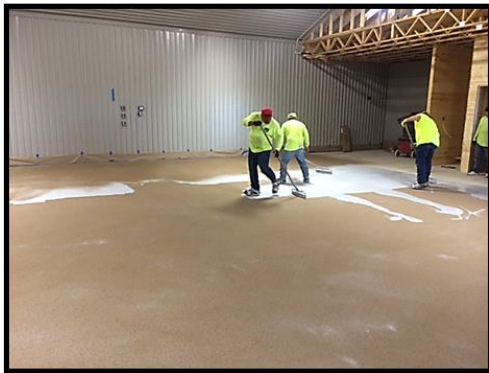
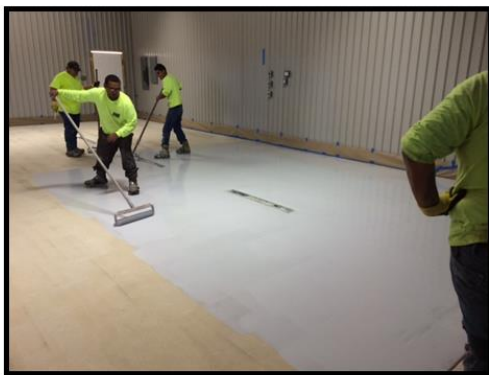
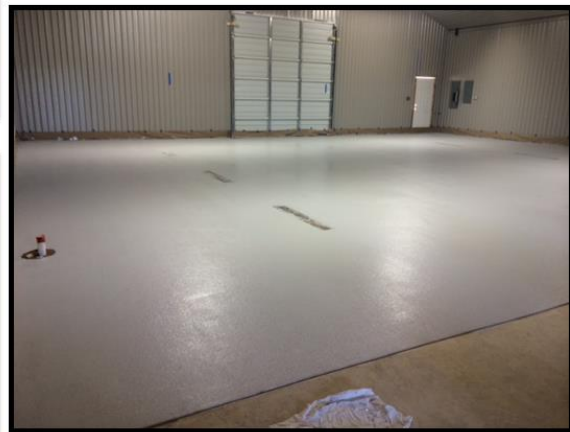
Kuhlman Cellars was in need of protecting their concrete in the blending/barrel storage area of their winery as the acids from the process of wine making are very aggressive and thus destructive to their slab. To accommodate the budget that the owner had allotted for flooring, we decided to go with a double broadcast of ICO Coat with an ICO Coat topcoat. They wanted a non-slip floor that would tolerate pallet jack traffic and occasional spill of wines that would also prevent concrete degradation from the acids of the wine.

The total area of the broadcast was 1,800 sq. ft. Floor preparations were with a shot blast machine while the edges were ground with dustless 7" diamond grinders. The concrete was new and in excellent condition with a 45 day cure. The floor took three days to complete including surface prep time and application of the two broadcast coats and topcoat. Final thickness was 1/8" and the client is very pleased with the look and function of their new floor.
