Case Study: Food Processing Plant- Service Hallways

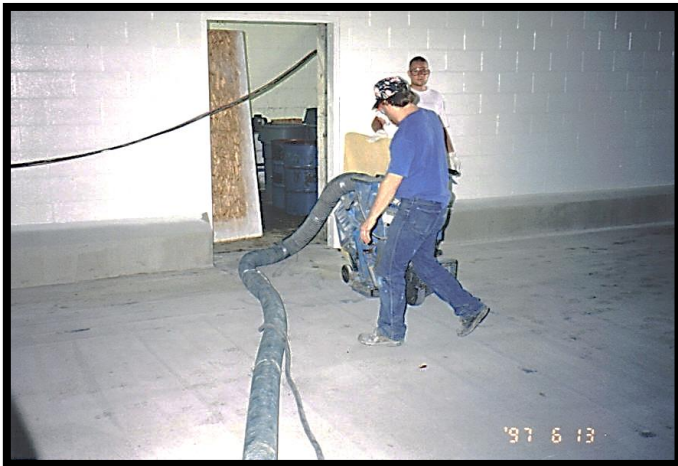
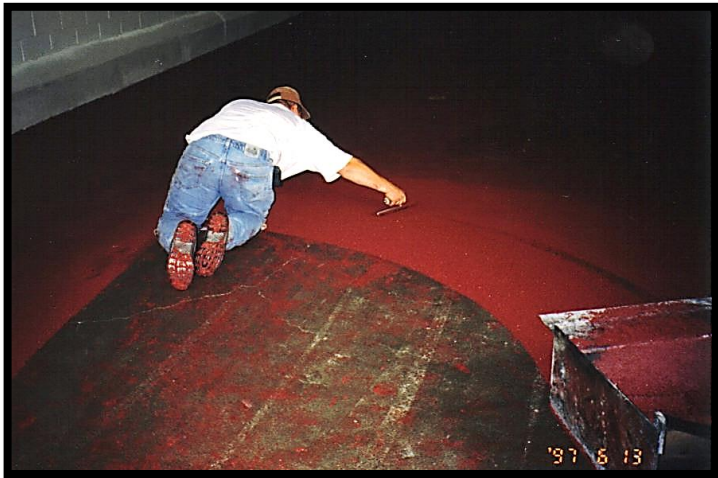
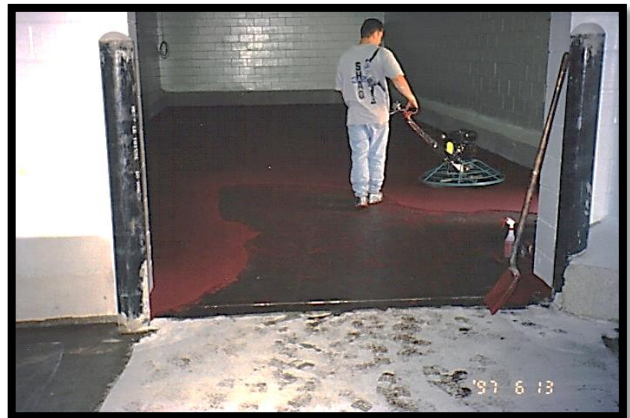
A Meat Processing company was required by U. S. D. A. to install an epoxy topping to a hallway connecting coolers and production areas due to concrete deterioration. Over time, chemical wash downs and heavy forklift traffic caused aggregate to be exposed. The concrete surface was shotblasted to remove surface contaminants and to provide the proper bonding profile. **3300 FS** epoxy mortar with primer was power troweled at a thickness of ¼" (6mm). The 2,500 ft.² (250 m²) project was completed in 2 days.

The sealed finished of the **3300 FS** has eliminated the standing water in the spalled concrete where the potential for bacteria growth existed. Wear from forklift traffic has also been greatly reduced. The **3300 FS** has been in service for 7 years and has required no additional maintenance.
