## Case Study: Veolia Solvent Recycling Facility

Veolia Environmental Services facility in West Carrollton, OH recycles industrial solvents. About 24 years ago it was coated with Milamar's ICO Super Guard, ¼" and they were pleased with how well the coatings performed standing up to the harsh chemicals (chlorinated solvents) that were present. A recent fire at the facility destroyed the solvent recovery portion of the plant and led to a complete rebuild of the inside processing and outside containment areas.

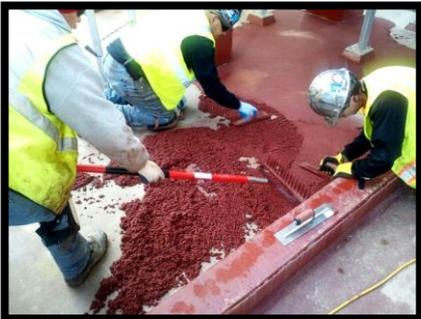
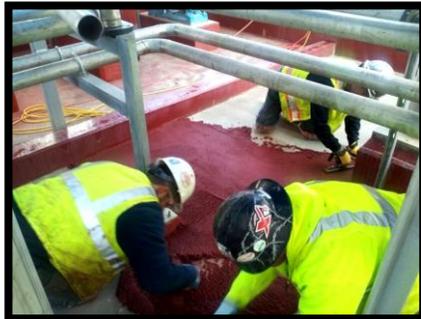
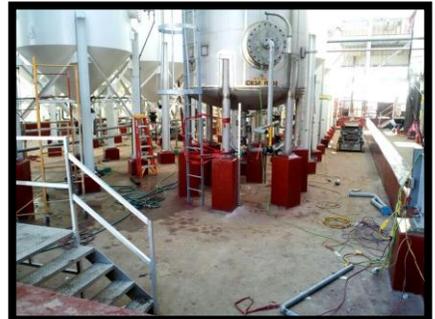
The project consisted of approximately 40,000 sq. ft. of ¼" Super Guard troweled floors with a 1" spoon cove. Wall protection included filling all bug-holes with ICO Gel, then two coats of ICO Hi Guard Coating GF @ 20 mils/coat, and an 8-10mil top coat of ICO Super Guard Coating. In addition over 5,000 sq. ft. of vertical tank pads and tank support legs were coated with the same system. One truck parking sump area was also coated with 1/8" ICO Hi Guard Liner with ICO Super Guard Coating.

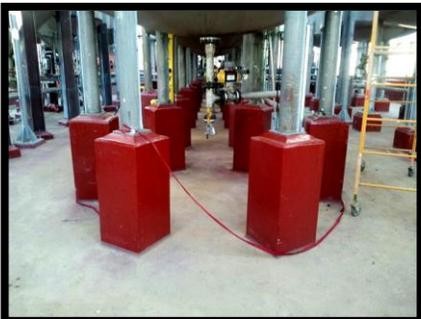
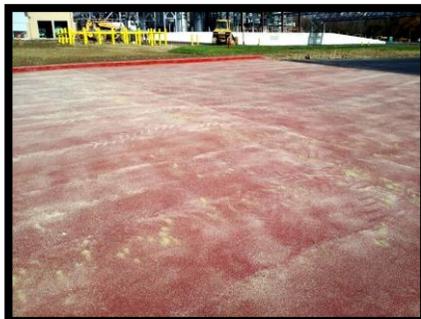
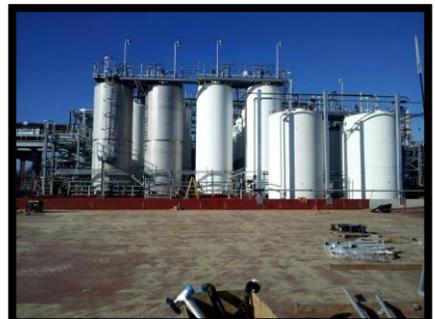
This was a very difficult and demanding installation for several reasons. With 50°F minimum application temperatures, FlorLine had to contend with scheduling around temperature variations, particularly as the project extended late into the year. This required tenting some areas, and providing heating blankets to new flooring work. The walls had extensive bug-holes, resulting in significantly more gelling than originally anticipated. A rainy construction season resulted in frequent pumping of water out of the containment areas, with little time left to dry the slab before application. Lastly direct exposure to sunshine forced crews to apply later in day after air temperatures were receding to reduce outgassing.
