Case History: Papé Machinery

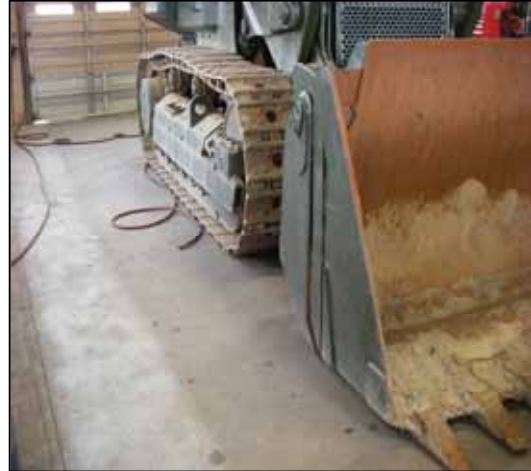
Papé Machinery is one of the west's largest construction and forestry equipment suppliers and has been around for almost seventy years. One of their dealers and service centers in Tacoma, WA was having problems with the concrete floors in their service bays. The floors were being badly damaged from the heavy equipment moving in and out, including large machinery having steel tracks and chains that provide traction in the mud and snow. These steel treads and chains in addition to the heavy weight of the vehicles were severely gouging and damaging the concrete. The Service Manager of Papé, contacted **Marty Hogan** of **Dunkin and Bush**, an International Coatings Certified Contractor, to see if they could come up with a solution to the problem.

Dunkin & Bush had installed International Coating's systems in demanding environments in the past with great success. They knew ICO Guard 51 was a tough and resilient material and thought International Coatings could help customize it with steel filler so that could withstand the conditions at Papé Machinery. **Marty** and ICO representative **Tim Rayburn** used the Iron Guard at a ¼" thickness in the areas where the heavy steel tracks would contact the floor. The combined a steel filler with the usual ICO Fill hand trowelled sand to make the system even more abrasion resistant
