## Case History: Skills, Inc. Aerospace Supplier

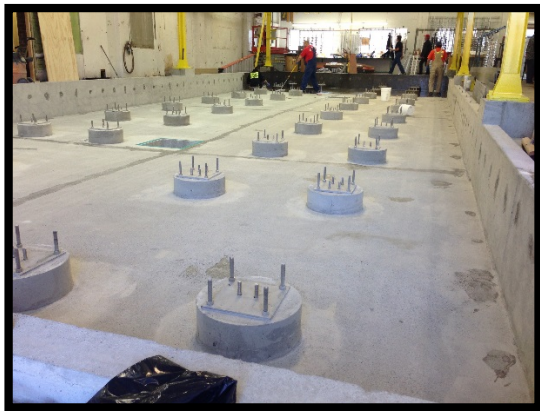
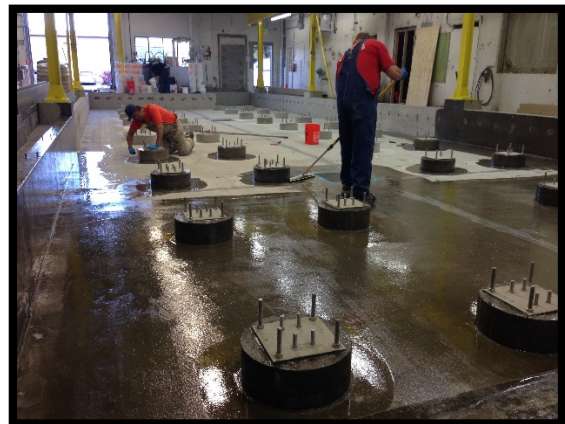
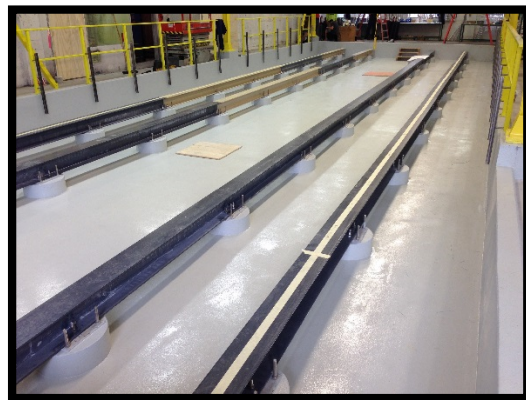
An area of concrete became saturated with chemicals after an old containment system had failed. Rather than clean and patch the old concrete, Skills Inc. chose to remove and replace the old concrete with new concrete. The picture below on the left shows the new concrete along with a new plating line. In addition to the new concrete the containment area needed to be chemically resistant, therefore ICO Primer LV and ICO Hi Guard resinous coatings were used to protect the new concrete and prevent the chemicals from leaking into the soil.

Local contractor Emerald City Shotblasting along with local Milamar representative Tim Rayburn discussed the appropriate system that should be installed. Since Skills Inc. utilizes a number of chemicals in their plating process, it was agreed upon that the ICO Primer LV and ICO Hi Guard were to be installed because the 2-part epoxy Primer LV and 2-part novolac epoxy coating ICO Hi Guard could handle their potential chemical spills. The 1,600 sq. ft. pit was prepared by shot blasting and grinding the new concrete giving a good profile for the coatings to adhere. An additional advantage to the flooring system used was the low odor of Primer LV and Hi Guard, which allowed the employees in the building to continue working during the install.

Skills Inc. is happy with the turnaround time on the applied material and its ability to withstand the chemicals. The job took a total of 5 days to complete which includes the surface prep and floor coating.
